Lessons learned from three failures on a high steep geogrid-reinforced slope

Chia-Nan Liu^{a,*}, Kuo-Hsin Yang^b, Yu-Hsien Ho^{a,c}, Chia-Ming Chang^c

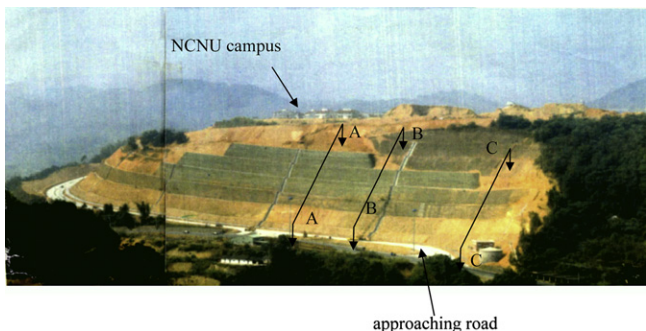
Fig. 1. Overall view of the completed reinforced slope.

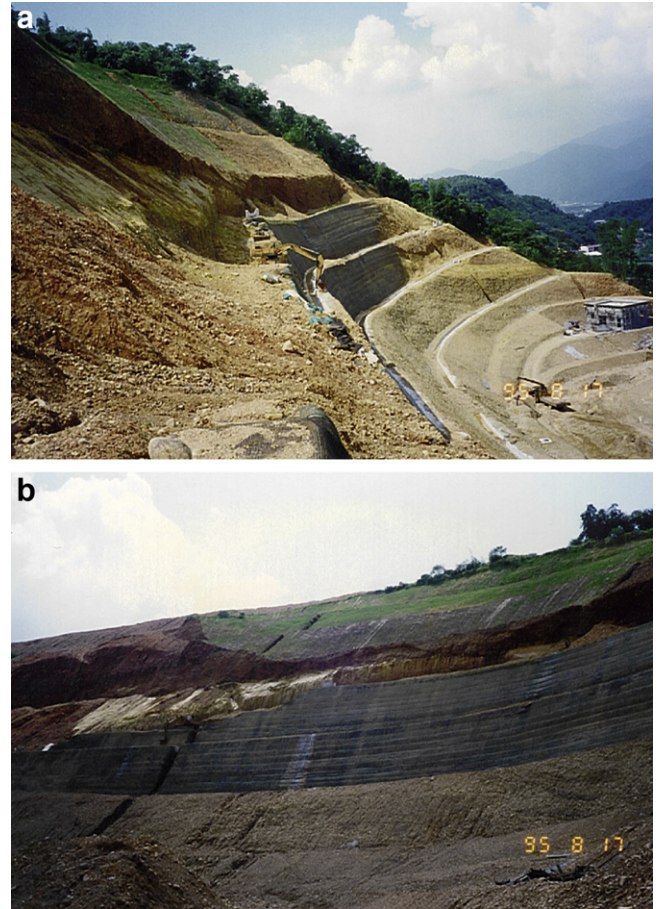
The sliding plane was along the interface of laterite gravel and underneath stiff brown-yellowish clay. As seen in Fig. 4, it is evident that the failure was closely related to the clay layer. We note that the existence of this clay layer was not shown on any design reports of this reinforced slope. For example, as shown in Fig. 5, the clay layer was not taken into consideration when conducting the original stability analysis of the four-tiered reinforced slope.

Fig. 4. Failure of reinforced slope at Section A-A during construction in 1994: (a) side view; (b) front view.

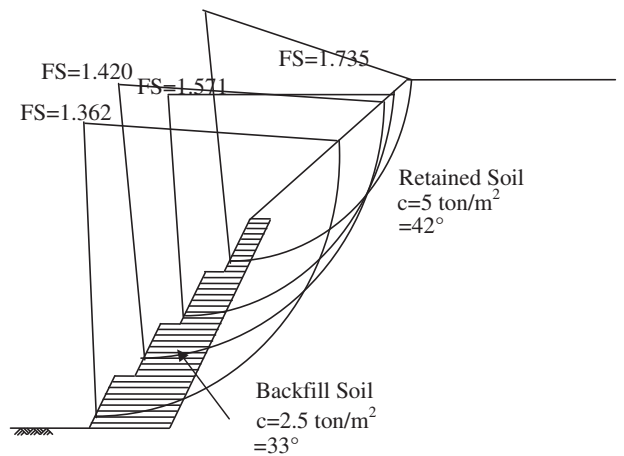
Fig. 5. Original stability analysis for the 4-tiered reinforced slope. Note that the clay layer was not included into analysis.

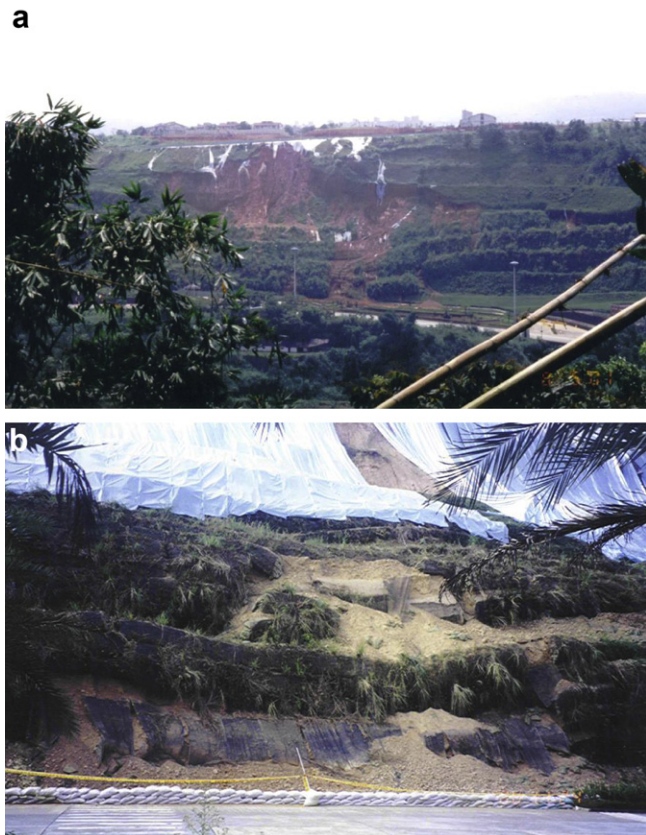
A careful field investigation was conducted to examine the reinforcement, with Fig. 6b presenting a close view of the failure at the slope's foot near Section A-A. Though the slide was over 20 m in elevation and 15 m in horizontal distance, most of the geogrid-reinforced layers in the upper three tiers remained intact, though there were gaps between them. These geogrid reinforcements were

Fig. 6. Failure of reinforced slope at Section A-A due to 1999 Chi-Chi earthquake: (a) overall view; (b) close view.

not horizontal as constructed, but rather rotated upslope at a small angle (as shown in Fig. 2). The extrusion of wrapped-around geogrid at some portion can be seen in Fig. 6b, especially at the bottom tier of the reinforced slope. This happened likely due to the large shear force from the sliding soil mass to extrude the wrapped-around geogrid out. Backfills collapsed and slid toward the slope's toe. About 4–5 layers of reinforced slope in the bottom level were not exposed, but they were buried by the geogrid reinforcement that slid down from upslope. No signs of rupture of the geogrid, nor piping, seepage, or moisturized soil were observed in the field. As seen in these photos, the reinforced zone and natural slope slid down along a significant failure surface, which was within the natural soil retained by the reinforced slope. This leads to a conclusion that the failure was closely related to global instability.

The rehabilitation of this failure began in 2002 and was finished in the spring of 2004. Fig. 7 shows countermeasures, including removing the debris of the slide, tapering the slope inclination to 27–34°, soil nailing, and placing a reinforced retaining wall at the slope's toe. The placement of reinforcement material was further examined on site during the rehabilitation. It was found that the overlapping width between geogrids was small, as most did not follow the common standard requirement of 10–30 cm. This defect easily allowed the gap to widen between the geogrid and the backfills to move out between gaps under a lateral loading condition. The embedded length of geogrid was also observed from the failed portion. The measured embedded reinforcement lengths were 30% shorter than the designed lengths. No trace of coarse gravel layer or geosynthetic drainage layer was found when the sliding debris was removed. This observation confirmed that the subdrainage was not installed in the original design of the reinforced slope.

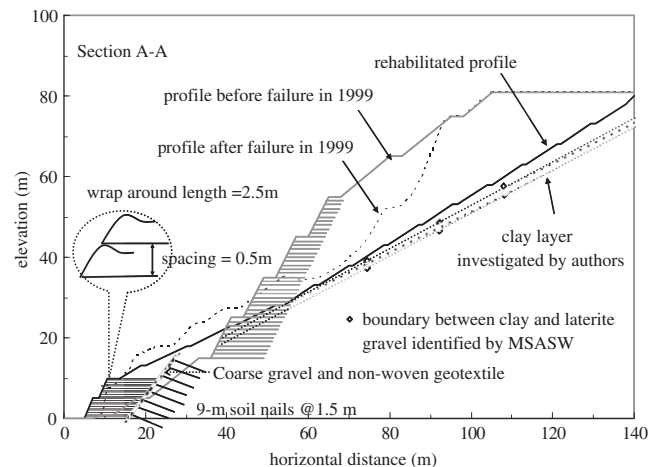
Fig. 7. Designed, failed and rehabilitated profiles for Section A-A with location of clay layer.

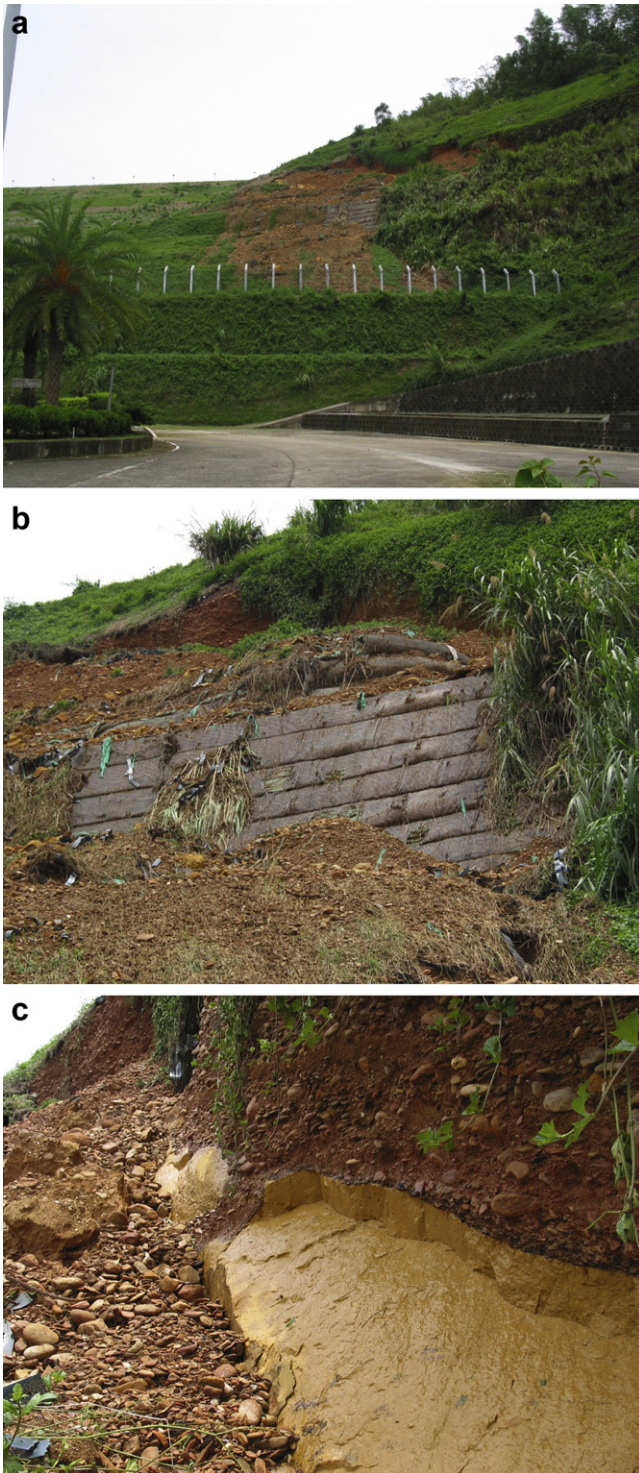
tier of the reinforced slope located below the sliding plane did not shear and remained basically intact (Fig. 8b). A moisturized brown-yellowish clay was also observed along the sliding plane (Fig. 8c). These observations lead to the conclusion that this failure was closely related to rainfall and the clay layer. The rehabilitated portions such as Sections A-A and B-B performed well during this rainstorm.

Fig. 8. Failure of reinforced slope at Section C-C due to typhoon induced heavy rainfall in 2004: (a) overall view; (b) close view; (c) clay layer observed along sliding plane of failure.

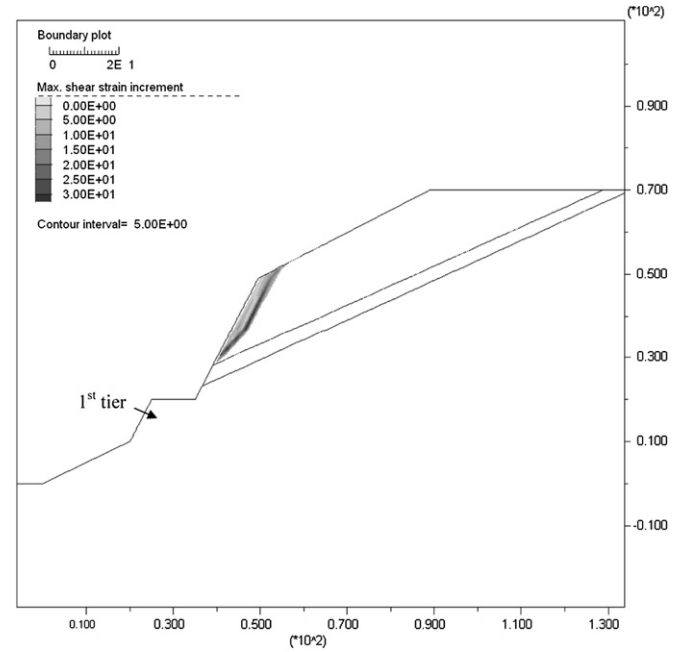
Fig. 13. Finite difference results of the 1994 slope failure at Section A-A at wet condition.

Fig. 13 shows the contour of maximum shear strain increment obtained from finite difference analyses. The finite difference results reveal that the slope failure was attributed to the stress concentration at the laterite gravel/clay interface. Failure started with a large shear strain that increased at the toe boundary of the lateritic gravel/clay interface and then propagated back into the natural slope until a shallow slide developed. In addition, it can be seen that the critical failure surface identified by the limit equilibrium analysis in Fig. 12 is comparable to the location of

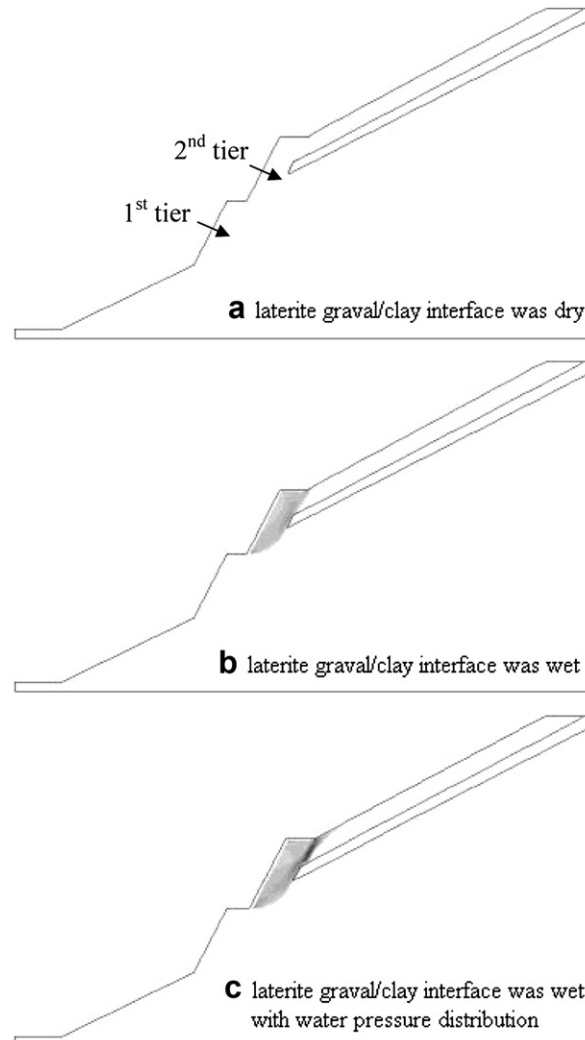
Fig. 18. FLAC analysis results of three scenarios for the 2004 slope failure at Section C-C: (a) dry interface; (b) wet interface; (c) wet interface with water pressure distribution.

In the subsequent finite difference analyses, three scenarios were investigated: laterite gravel/clay interface was dry, wet, and wet with water pressure distribution. The analysis result shows that the shear strain increment within the slope is insignificant for the scenario of dry laterite gravel/clay interface (Fig. 18a). However, shear strength began to develop for the scenario of wet laterite gravel/clay interface (Fig. 18b). The shear strain increment accumulated at the boundary of the backfill zone and the retained zone where the transient water pressure was induced by the rainfall infiltration for the scenario of wet interface with water pressure distribution (Fig. 18c). The shear strain increment extended upslope along the back of the reinforced zone and then into the natural slope to form a shallow sliding surface.
