Landslides

DOI 10.1007/s10346-023-02208-2 Received: 3 August 2023 Accepted: 28 December 2023 © Springer-Verlag GmbH Germany, part of Springer Nature 2024 Shih-Hao Cheng • Kuo-Hsin Yang • Shih-Yuan Lin • Chen-Kan Liao • Hung-Jiun Liao

A modified lift-off test for restressing anchors of a rehabilitated landslide slope

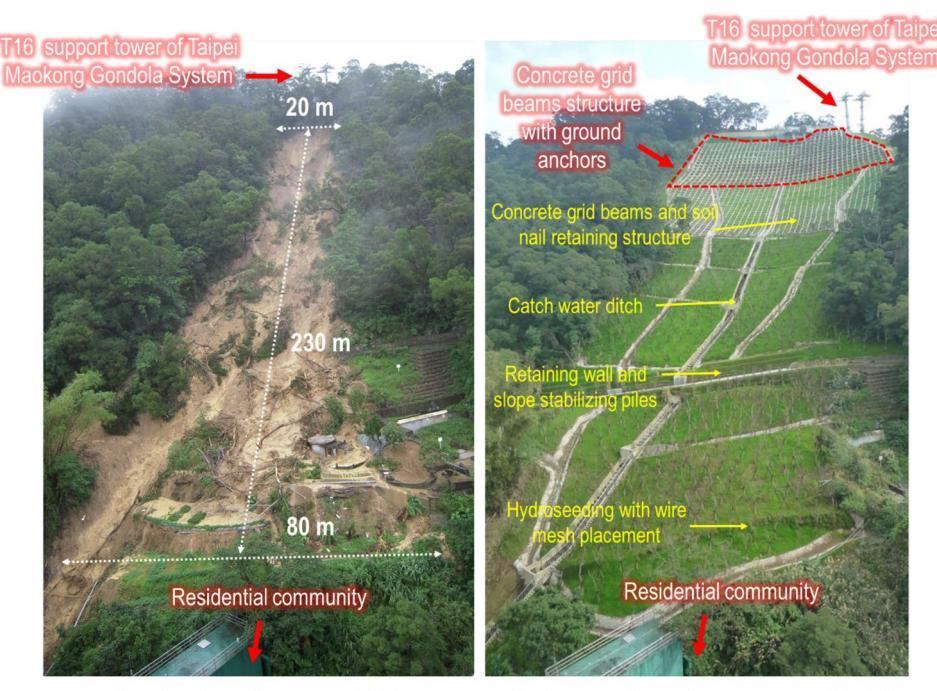
In September 2008, a shallow-slope landslide occurred downhill of the T16 supporting tower of the Taipei Maokong Gondola System due to Typhoon Jangmi. This landslide was attributed to topographic changes (i.e., headward erosion), geological conditions (i.e., colluvial soil layer up to a thickness of 2-6 m), and heavy rainfall (i.e., cumulative rainfall reaching 500 mm within 24 h). As illustrated in Fig. 4a, the collapsed area had a length of approximately 230 m, a width ranging from 20 to 80 m, a total area of about 1.2 ha (12,000 m²), and a landslide volume of roughly 30,000 m³ (Yang et al. 2017; Nguyen et al. 2022). Significantly, the upper and lower edges of the landslide area contained crucial structures that needed protection. The upper edge provided stability for the base of the T16 support tower, while the lower edge ensured the safety of the residents' community of the slope. A comprehensive design was implemented for landslide remediation, involving the installation of various slope stabilization structures such as stabilizing piles, ground anchors, soil nails, horizontal and vertical water ditches for drainage, and wire meshes for hydroseeding (Fig. 4b).

Fig. 4 Case study of the anchored slope near the T16 support tower of the Taipei Maokong Gondola System: a large-scale shallow landslide in 2008 and b remediation condition in 2010

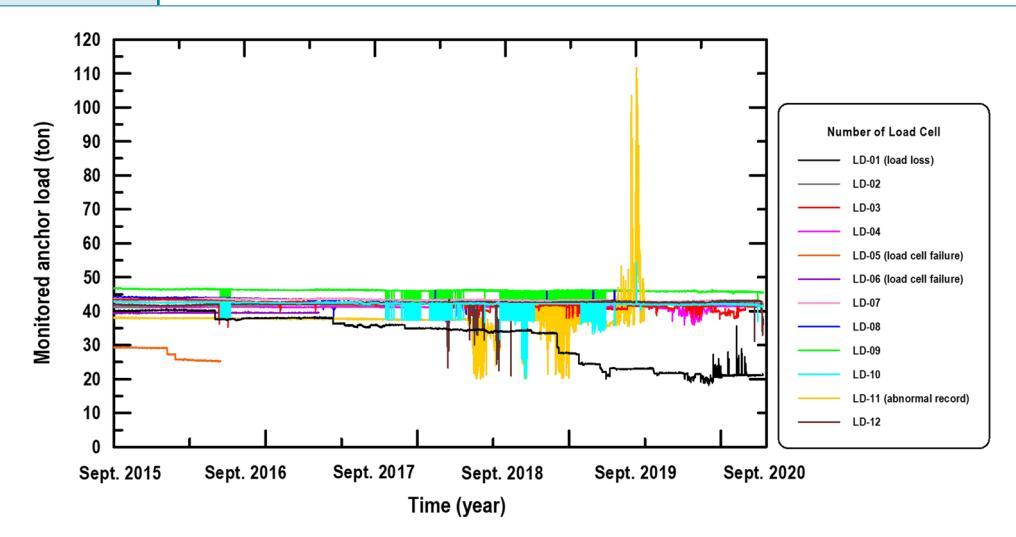
most load cells could record data without interruption, although their readings were occasionally unstable due to environmental temperature changes (Cheng et al. 2022). Meanwhile, the recorded data indicated that the long-term load ranged between 0.9 T_{w} and 1.2 T_w (36–48 tons). According to the Taiwan freeway asset management handbook (MOTC 2018), the residual load level was grade D, indicating that the ground anchors were in good condition (Liao et al. 2019). However, some abnormal load cell readings were identified. The LD-01 load cell exhibited a continual decrease in load, and its residual load was less than 0.5 T_w in 2020, indicating a grade B ground anchor. The LD-11 load cell exhibited anomalies in its records. The LD-05 and LD-06 load cells were damaged in 2015 and 2016, respectively, and could not precisely record data during these years. The information above indicates that as much as 33% (4 out of 12) of the load cells did not function properly, reducing the reliability of the monitoring results.

Fig. 8 Long-term loads recorded from the load cells between September 2015 and September 2020

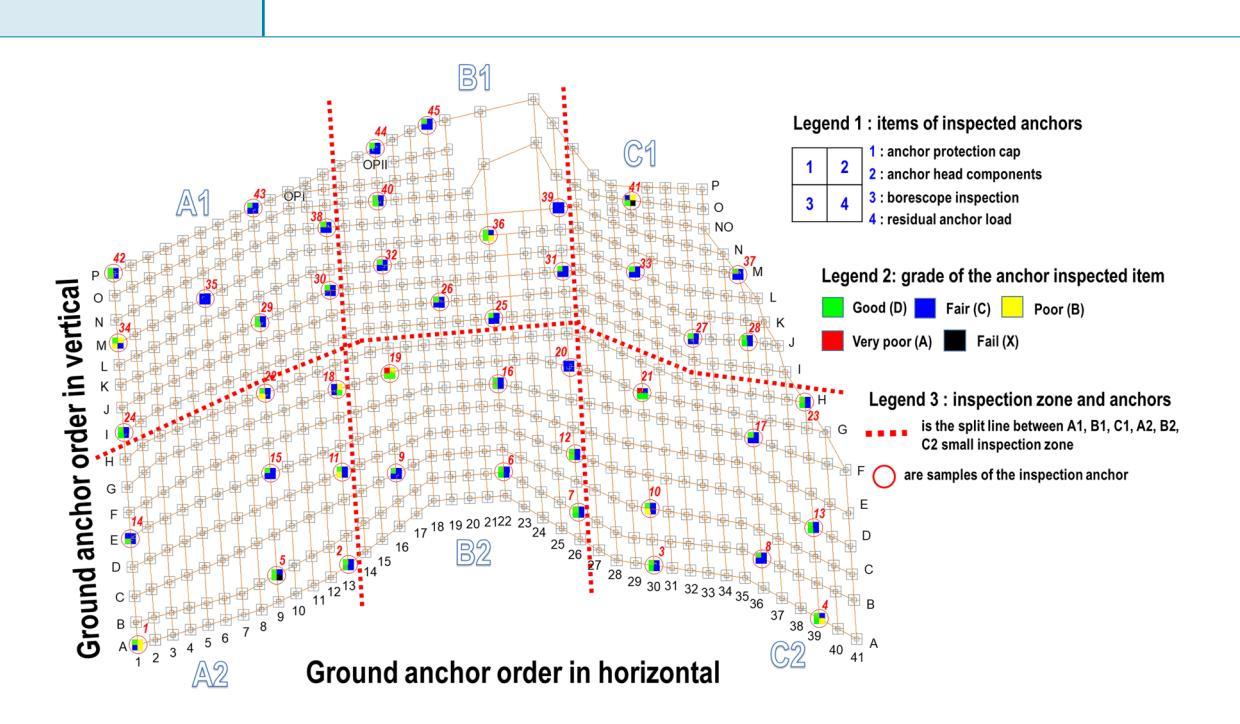
Step 1: visual inspection of the protection cap of the anchor. The protection of the anchor head was a concrete cap. In visual inspections, the majority of the 45 inspected anchors showed no damage or corrosive groundwater flow, with 43 anchors belonging to grades C and D (approximately 95% of the inspected samples). For the remaining 2 anchors, namely, anchor nos. 19 and 21, the protection cap was separated by \geq 2 mm from the bearing plate; hence, these anchors were classified into grade A (Fig. 9).

Fig. 9 Layout of the anchors selected for function inspection and the grading results for each step on the inspected anchors

The steel strands and wedge components at the anchorage head were investigated after breaking the concrete protection cap. These investigations revealed that 40 (89% of all inspected anchors) belonged to grade C. The remaining 5 anchors (anchor nos. 1, 18, 19, 34, and 41) exhibited corrosion areas exceeding 50% of the surface area of the steel strands or anchorage head; thus, they were classified as grade B (Fig. 9).

The slope anchors were installed for permanent corrosion protection. The free length of each strand was covered with a polyethylene tube and filled with grease to prevent corrosion. Anticorrosion quality was verified through a borescope inspection; 41 (91% of all inspected anchors) were classified as grade C or D in step 3. For the remaining four inspected anchors (anchor nos. 10, 11, 22, and 34), rust texture was observed on the strand surface, and the corrosion areas covered approximating 50%–90% of the strand surface; thus, these anchors were classified as grade B (Fig. 9).

Step 4: lift-off test to determine the residual anchor load. Investigated anchors nos. 1, 4, and 36 had residual loads that exceeded 0.2 T_w but were less than 0.5 T_w ; thus, these anchors were classified as grade B. Anchor nos. 5 and 41 were classified as grade X because they were pulled out during the lift-off test. The remaining 40 investigated anchors (89% of all the inspected anchors) were classified as grade C or D. These anchors exhibited a marked load loss of approximately 8–20 tons (0.2–0.5 T_w), with 0.5 $T_w < T_r \le 0.8 T_w$ (Fig. 9).

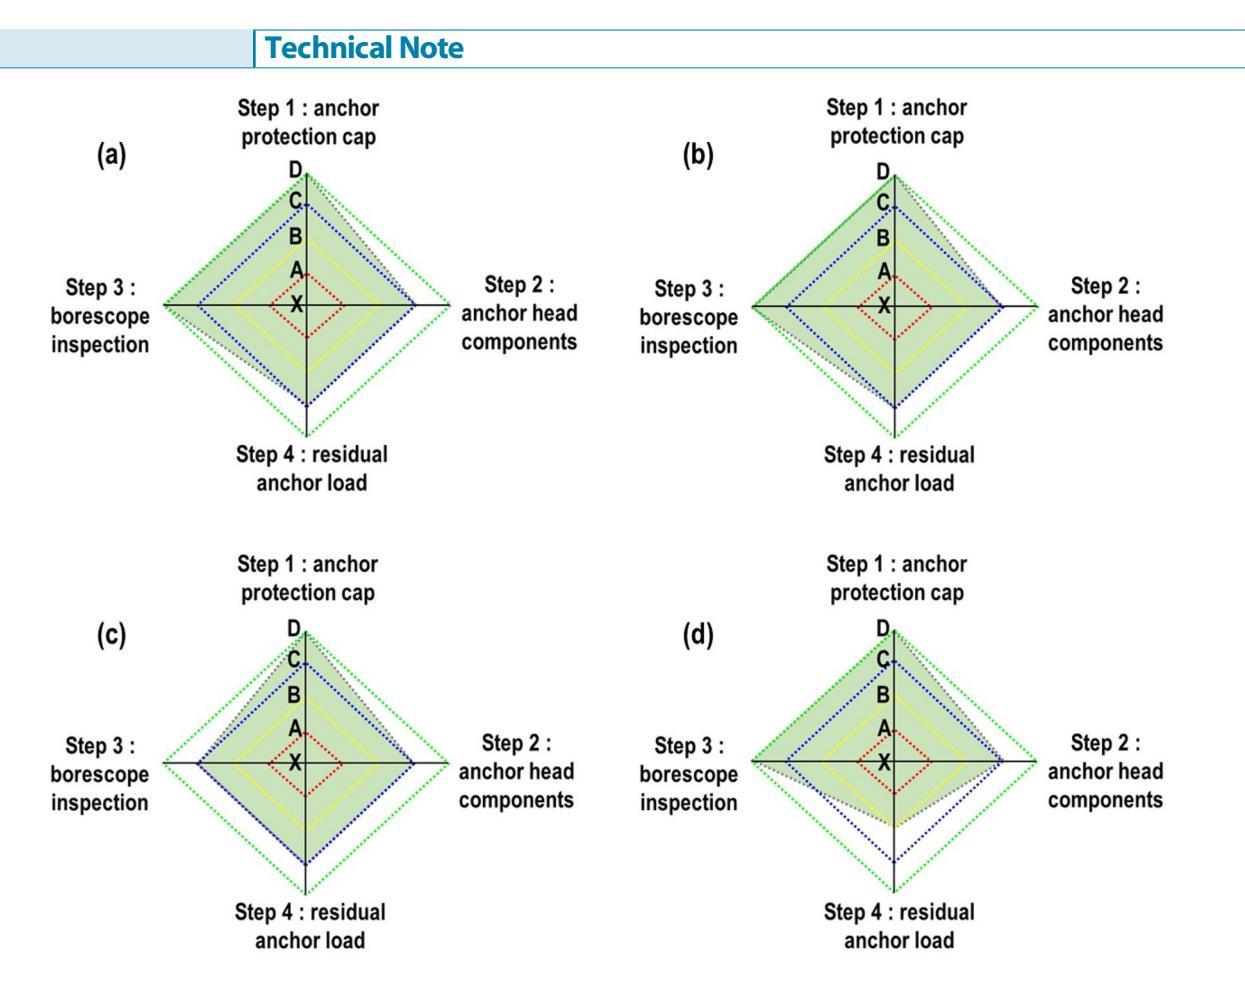
Fig. 10 Radar charts of the inspected anchors: a inspected anchor B-22 (anchor no. 6), b inspected anchor F-22 (anchor no. 16), c inspected anchor I-22 (anchor no. 25), d inspected anchor M-22 (anchor no. 36)

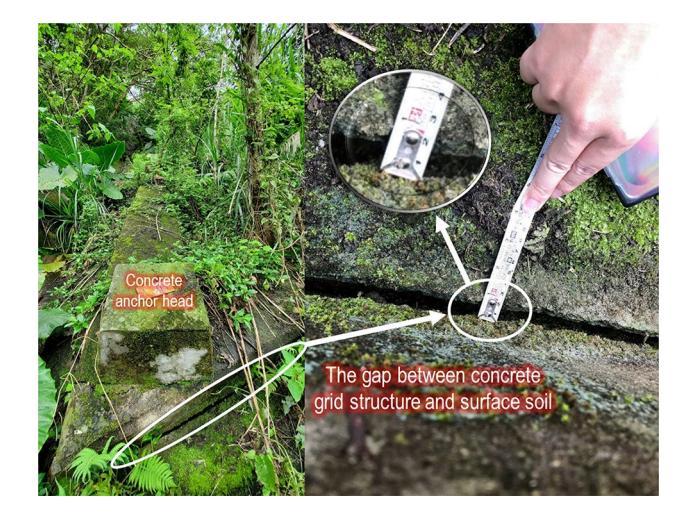
and shale layers (Fig. 11). This result supports the validity of the earlier inference that identified the residual layer as the cause of the compression and settlement observed in the concrete grid beam.

Fig. 12 Gaps between the concrete grid beam and the ground surface observed from the anchored slope (1–2 cm)

This conclusion is further substantiated by the presence of a 1–2 cm gap observed between the concrete grid beam and the surface soil on the slope (Fig. 12).

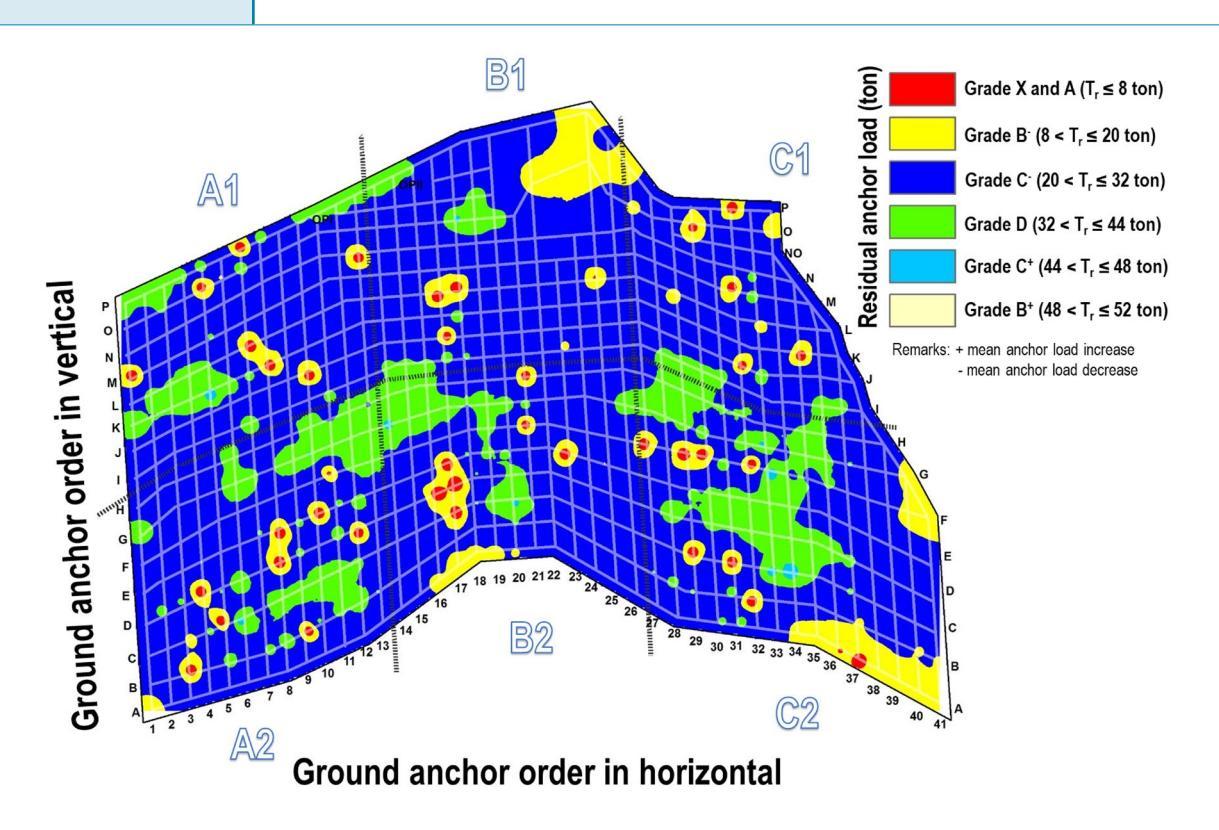
Fig. 14 Distribution of the residual load for all ground anchors in the anchored slope

Figure 14 displays the distribution of all the residual anchor loads in the anchored slope. The residual load level was classified as grade C, and most of the residual loads were ranging from 20 to 32 tons, and the load loss being approximately 8–20 tons (0.2–0.5 T_w). This result is consistent with the previous functional inspection results. The figure also indicates that about 7% (41 out of 574 anchors) of the anchors might fail (grades A and X) during the modified lift-off test. Typically, when the modified lift-off test is carefully executed, the failure ratio may vary based on the construction quality of the ground anchors, their service life, and the influence of the surrounding environment.

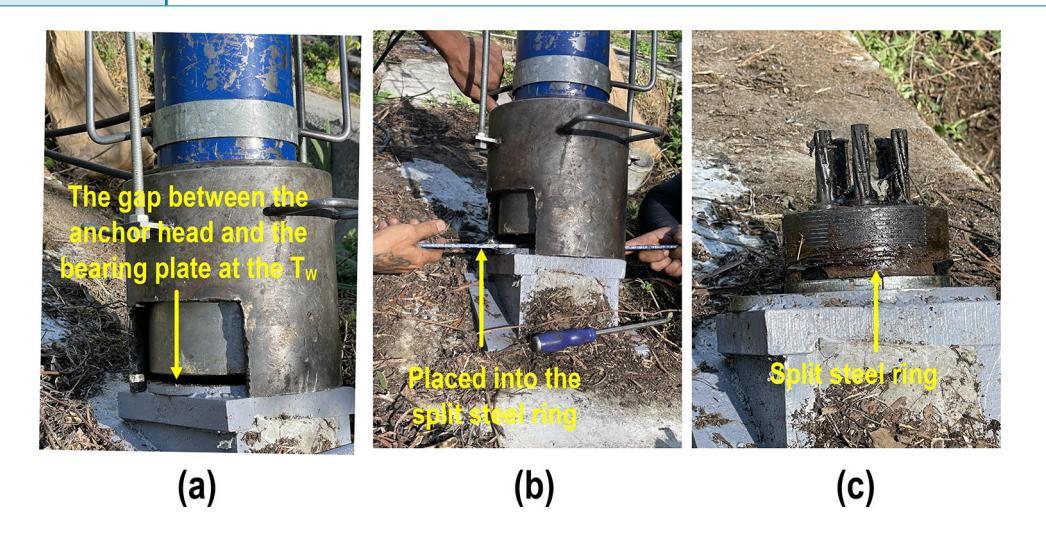
Fig. 17 Photos of the restressing procedure performed in the modified lift-off test: **a** the gap between the anchor head and bearing plate at the design load, **b** holding the anchor head at the design load and placing a steel split ring in the gap between the anchor head and the bearing plate, and **c** removing the lift-off load from the anchor head and completing the restressing process

Based on the results of slope stability analyses under different conditions for the slope, to ensure the anchored slope stability beneath the T16 tower and safeguard the residential community downhill, it is suggested that the load of the anchors experiencing load loss should be increased to the designed load (T_w) through restressing to maintain the design performance. The existing anchors underwent the modified lift-off test to investigate their residual loads, evaluate their anchoring conditions, and synchronize to achieve the restressing. Similar to Fig. 3, when increasing the load to the design load (T_w) , a split steel ring of appropriate thickness must be placed into the gap between the anchor head and the bearing plate by using simple tools to achieve restressing (Fig. 17). Because the load to be increased for each anchor is different, the size of the gap between the anchor head and the bearing plate is not fixed. Therefore, split steel rings with thicknesses of 3, 5, and 10 mm (Fig. 18) were used to provide flexibility in the restressing procedure. In this case, a split steel ring with a thickness of approximately 1.5 mm is required to increase the load by 1 ton {= [ΔP (load charge) × L_{eff} (effective free-strand length)] / [E (Young's modulus of the steel strands) $\times A$ (crosssectional area of all the engaged steel strands)] = $(1000 \text{ kg} \times 15, 0)$ oo mm) $/(2 \times 10^{6} \text{ kg/cm}^{2} \times 4.9355 \text{ cm}^{2})$.

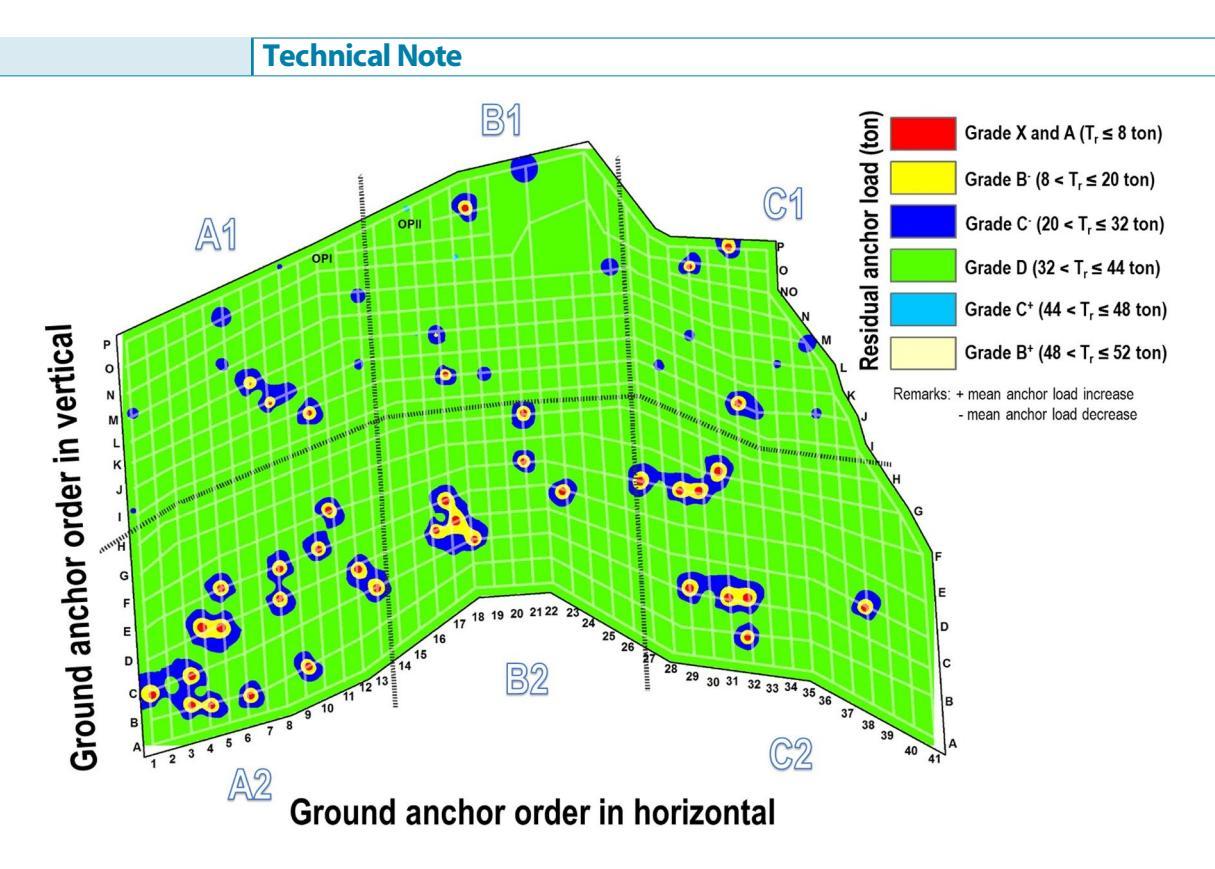
Fig. 19 Load distribution on the anchored slope after performing restressing in the modified lift-off test

Figure 19 displays the load distribution of all anchors on the anchored slope after performing the modified lift-off test (restressing procedure). It indicates that the loads of most anchors were restored to the design load level (grade D). However, as stated above, during the implementation of the modified lift-off test, approximately 7% of the anchors might fail due to phenomena such as the broken failure of strands and the pull-out occurring at the fixed end. These anchor failures mostly occurred when investigating the residual load and not during the restressing stage, and this study adopted a principle of one-to-one reinforcement for each failure to restore the original design performances. There are 43 reinforced anchors installed on the anchored slope (2 and 41 anchors were reinforced because of failures found during stages 1 and 2 of the investigation, respectively). Figure 20 depicts the load distribution of the anchored slope after reinforcing the anchors; all the anchors were rehabilitated to the design load (T_w) of 40 tons.

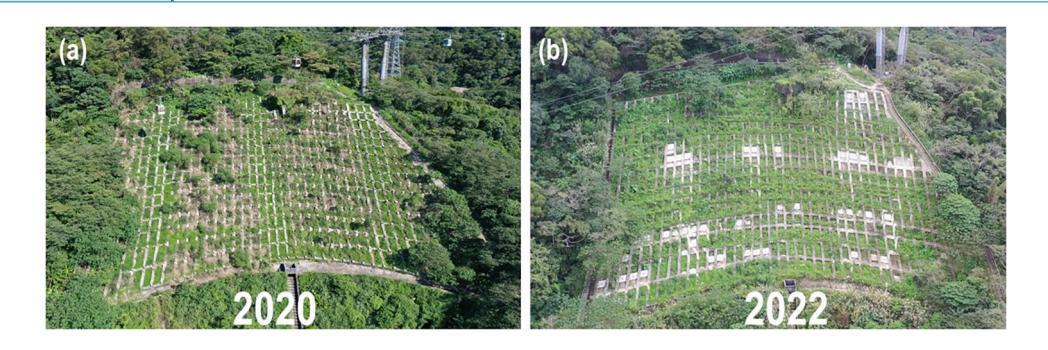
Fig. 21 Comparison of the anchored slope before and after restressing: **a** before restressing in 2020 and **b** after performing restressing in the modified lift-off test in 2022

slope to the initial design condition by adopting modified liftoff tests. Although 43 anchors had to be reinforced, this number is only approximately one-fifth the number of anchors that must be installed in a conventional approach; this result highlights the advantages of the modified lift-off test for restressing in terms of reducing construction time and costs. Moreover, as displayed in Fig. 21, the measures adopted in this study did not add a substantially higher number of concrete structures to the original anchored slope; thus, these measures are environmentally friendly and contribute to sustainable development.
