Failure investigation of a geosynthetic-reinforced soil slope subjected to rainfall

ABSTRACT: This paper presents a comprehensive failure investigation of a geosynthetic-reinforced soil (GRS) slope subjected to rainfall. The investigated slope is a 26-m high, four-tier, geogrid-reinforced structure backfilled with low plasticity silty clay that contains more than 60% of fines. The GRS slope first exhibited excessive deformation after typhoons and heavy rainfall from 2010 to 2012. The slope collapsed in 2013 due to two sequential typhoon events with a total accumulated rainfall of more than 600 mm. The slope failed in a compound failure mode in which the failure surface partially cut through the reinforced zone and partially passed along the interface between the weathered sandstone and intact shale. By using the recorded rainfall, site geology, and measured soil and reinforcement parameters, a series of coupled hydro-mechanical finite element analyses were performed on the basis of the unsaturated soil mechanics to examine the failure mechanism and factors triggering the slope failure. The numerical results indicated that the slope failure occurred due to the development of positi

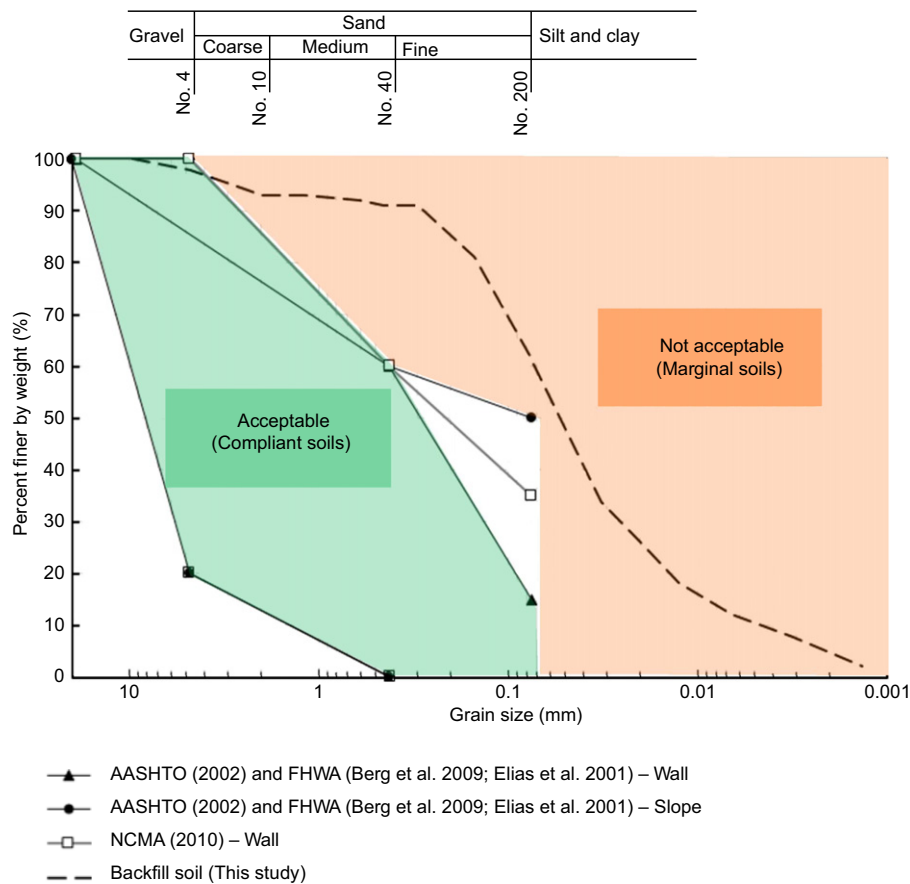
Figure 1. Grain size distribution of backfill in this study and as recommended by design guidelines

Geosynthetic-reinforced soil (GRS) structures are widely constructed because of their economic advantages and successful performance. GRS structures are typically composed of four components: backfill soil, reinforcement, facing, and drainage. Among these components, the backfill material has a major effect on the suitability and applicability of the GRS structures – for example, cost, transportation, environmental concern, and stability (Christopher and Stuglis 2005; Raisinghani and Viswanadham 2011). Design guidelines (Elias *et al.* 2001; AASHTO 2002; Berg *et al.* 2009; NCMA 2010) suggest the use of good quality soil (i.e. granular soil) as backfill, because of its high permeability, for preventing the development of porewater pressure (PWP) within the soil. Figure 1 displays the gradation limits for backfills

suggested in the design guidelines. In addition to the gradation limits, the plasticity index of the backfill is also specified ($PI \leq 6$ and 20 for walls and slopes, respectively). Notwithstanding that the use of fine-grained soils as backfill does not meet the grain size recommendations specified in the design guidelines (usually referred to as marginal fills), many areas where granular backfill is not readily available adopted locally available soils containing certain fines as alternative backfills to minimize transportation cost and environmental impact. Moreover, the marginal soils were adopted to adhere to a local regulation that specifies that the excavated and backfilled soils at the construction site should be balanced.

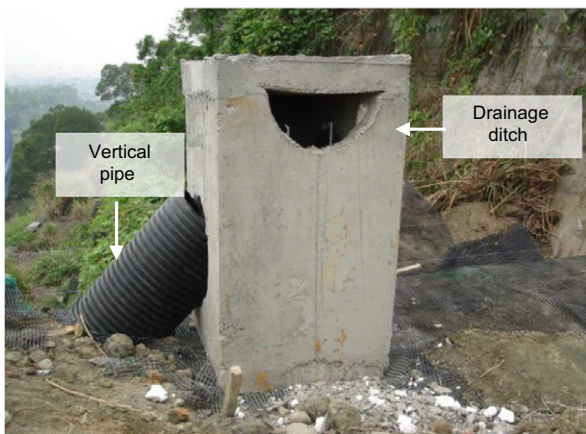
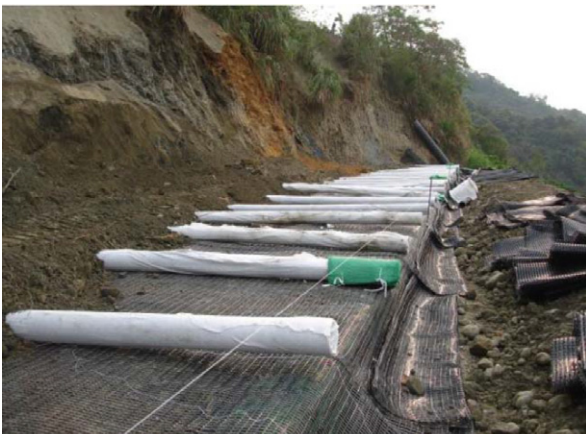
Figure 3. Drainage system: (a) joint between back drain and transverse pipe; (b) joint between drainage ditch and vertical pipe; (c) transverse pipe wrapped in nonwoven geotextile (images provided by Taiwan Professional Geotechnical Engineers Association)

loosely connected. No flexible joint was applied at the connection. When the slope deformed, these joints could easily become disconnected, and consequently the drainage system could malfunction.

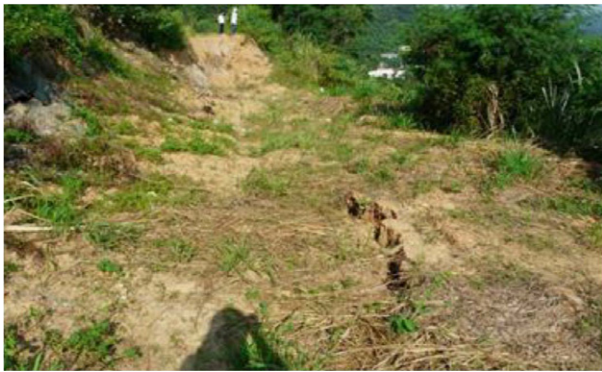
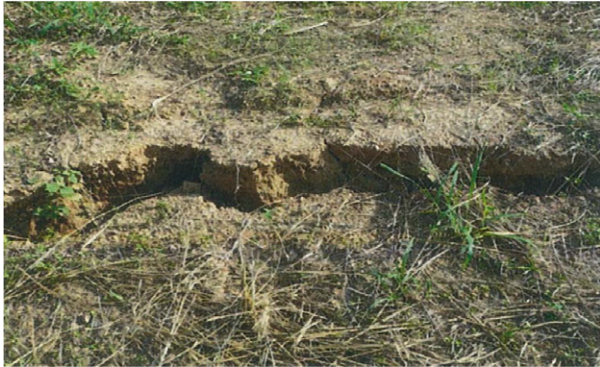
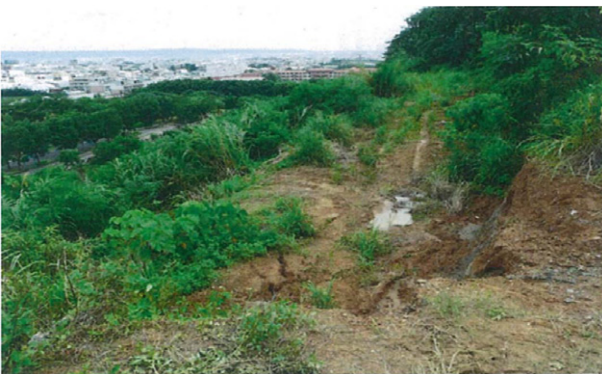
Figure 5. Development of tension crack and slope settlement during the rainy season in 2012: (a) tension crack; (b) onset of settlement; (c) excessive settlement over 1 m (images provided by Taiwan Professional Geotechnical Engineers Association)

During the rainy season of 2012, the slope was subjected to a significant amount of rainfall from the plum rain (total precipitation $R = 187$ mm) in May, Typhoon Talim ($R = 350$ mm) in June, torrential rainfall ($R = 243$ mm) in July, and Typhoon Saola ($R = 563$ mm) in August. During this period, tension cracks and slope settlement regenerated and gradually developed as the rainfall continued. Figure 5 displays subsequent photographs of the development of the tension cracks and slope settlement with time. A slope monitoring program was immediately initiated to measure the top settlement and facing deflection of the third and fourth tiers of the GRS slope for a period of 7 months from June to December 2012. On the basis of the monitoring results, the maximum slope settlement and facing deflection measured on the fourth tier approached 140 and 80 cm, respectively. Figure 6 illustrates the measured slope settlement at different locations (A01–03, as shown in the insert in Figure 6) on the top of the fourth tier during this period. Clearly, the slope settlement directly correlated to rainfall: the slope settlement substantially developed from June to September 2012 during the rainy season and stopped intensifying from October to December 2012, when slight rainfall was observed. The slope was repaired again, and the top of the slope was waterproofed with a layer of controlled low strength material (CLSM) underlain by a geomembrane to prevent rainfall infiltration.

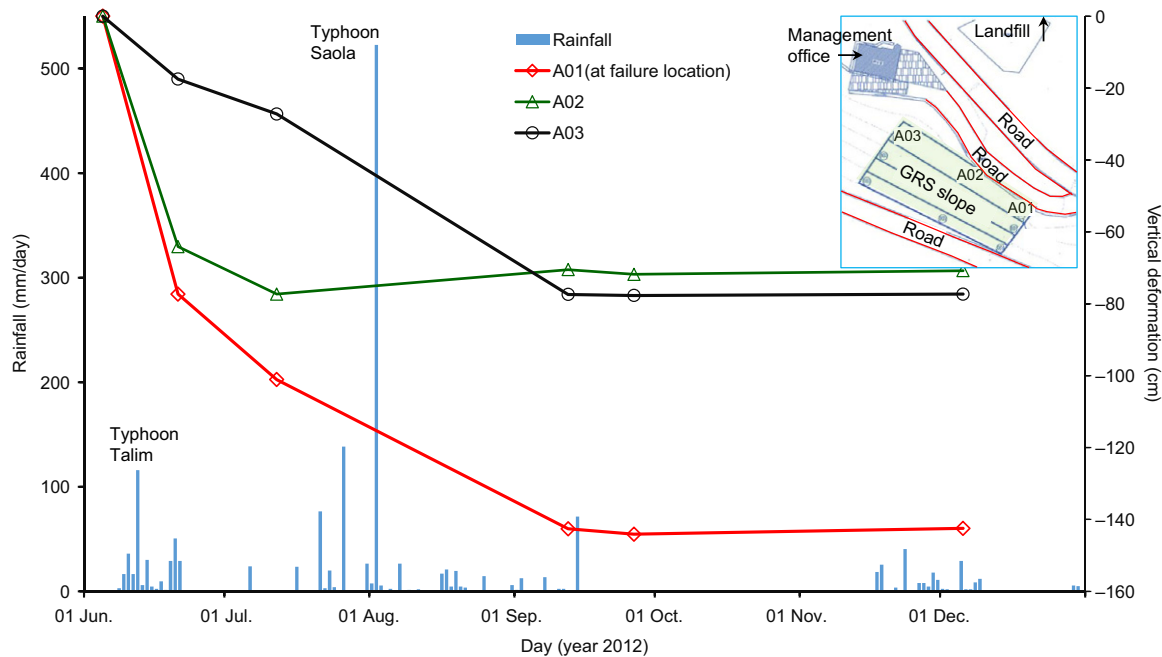
Figure 6. Relationships between rainfall and slope settlement (negative deformation value indicates settlement)

The slope finally collapsed on 1 September 2013, which is around 3 years after completing the construction of the slope. The slope collapse was triggered by two consecutive typhoon events – Typhoon Trami ($R = 338$ mm) from 20 to 24 August 2013, and Typhoon Kongrey ($R = 310$ mm) from 29 August to 1 September 2013. Although the total precipitation of Typhoon Kongrey was less than that of Typhoon Saola in 2012, the two typhoon events occurred almost continuously and brought a total precipitation of 648 mm within 10 days. This comparison suggests the antecedent rainfall (i.e. the rainfall event prior to the major rainfall event) has an important role in influencing the stability of the GRS slope.

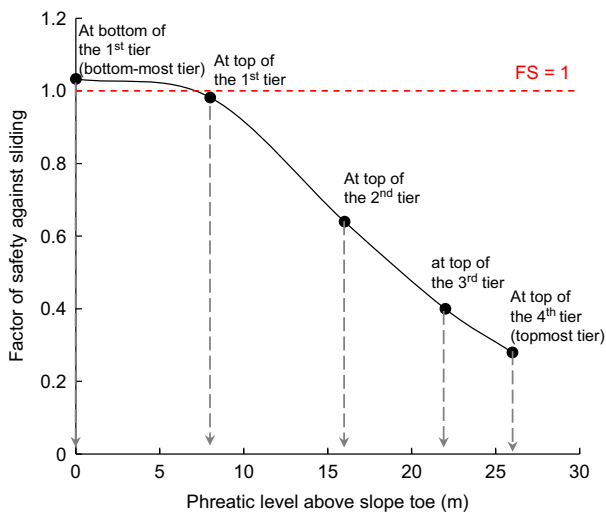
Figure 9. Estimated external stability against sliding at different phreatic levels

The second problem in the original design is that the external stability of the slope was not evaluated. On the basis of the field observation and numerical interpretation as discussed later, the GRS slope was pushed by the lateral earth pressure, and sliding occurred at the bottom of the slope as the phreatic surface within the slope rose to a critical level. To evaluate the external stability of the GRS slope against sliding, the conventional sliding

block analysis (Samtani and Nowatzki 2006; Elias *et al.* 2001; Berg *et al.* 2009) was performed by assuming that the GRS slope was a rigid block subjected to the driving forces consisting of active earth pressure from the weathered sandstone and PWP accumulated at the slope back. The effect of suction could affect the earth pressure (Vahedifard *et al.* 2015, 2016a 2016b), but it was not included in the analysis of external stability because this effect is typically not considered in the conventional design. Figure 9 displays the calculated FS against sliding under various assumed phreatic levels. Clearly, the sliding failure occurred ($FS < 1$) when the phreatic surface rose near the top of the first tier. This phreatic level is in agreement with the level predicted by the coupled hydro-mechanical analysis presented later.

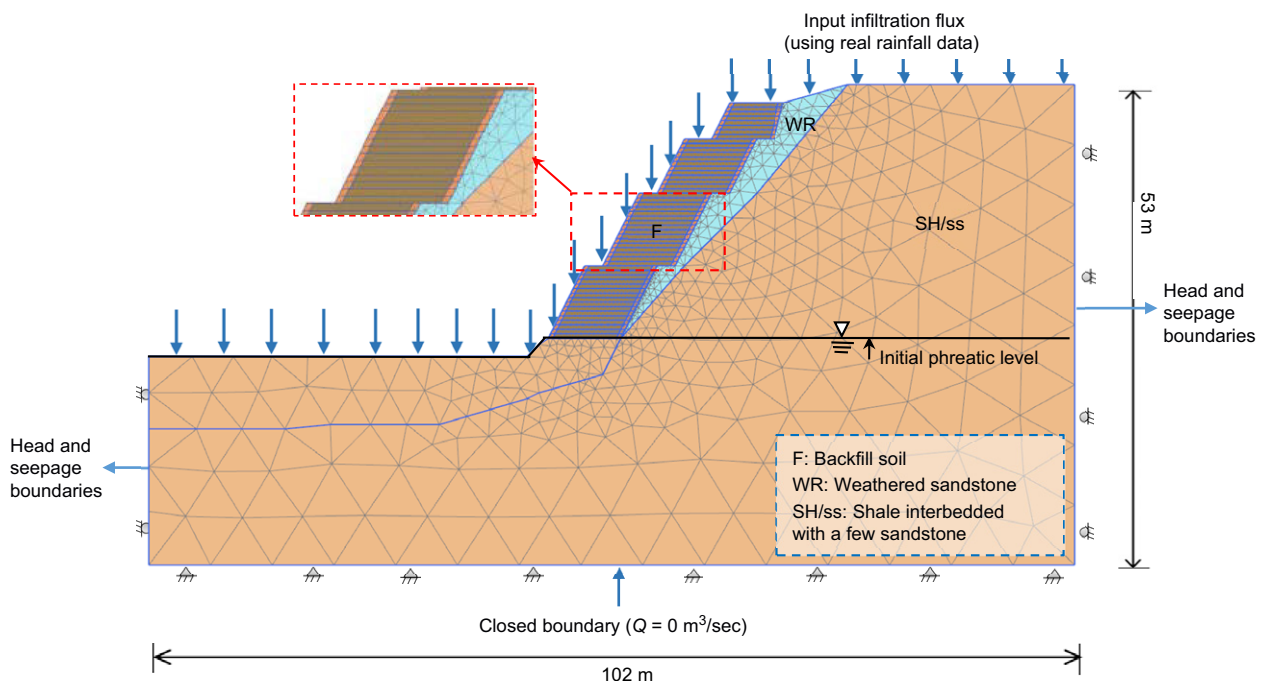
Figure 10. Numerical mesh and boundary conditions

Figure 10 displays the FE model of the GRS slope. The model geometry was constructed according to the topographic map and subsurface soil profile interpolated from the borehole logging readings. Backfill soil (F), weathered sandstone (WR), and fresh shale interbedded with a small amount of sandstone (SH/ss) were considered in the analyses. The numerical model consists of a total of 2685 15-node triangular elements. On the basis of the observed failure mode, because only the backfill soil and weathered rock layer were substantially influenced by rainfall

Hydraulic and mechanical boundary conditions prescribed in the numerical model are also illustrated in Figure 10. The standard fixity was applied as the mechanical boundary – the two lateral boundaries were allowed to move only in the vertical directions, whereas the bottom boundary was restrained from movement. Examination of the developed stress levels in the numerical models revealed that the assumed mechanical boundary conditions were appropriate.

Hydraulic boundaries at the two lateral ends were initially set to be constant head boundary conditions on the basis of the assumed phreatic level at the toe of the slope (Figure 10). During the analysis, the hydraulic boundaries were switched to the seepage boundary conditions to enable variations in the phreatic level during the wetting and drying cycles. A closed boundary was applied to the base of the slope model to limit the water flowing in and out. Downward vertical influx was prescribed on the slope surface to model rainfall on rainy days, whereas upward influx was imposed on the surface boundary to simulate evapotranspiration on dry days. The input values of downward flux during rainfall were obtained from the actual rainfall records from the nearest rainfall station established by the Taiwan Central Weather Bureau. The value of the upward flux on dry days was estimated to be 6 mm/day in this area, on the basis of the studies on the average evapotranspiration rate of the mountain areas in Taiwan (Chen *et al.* 2005; Hsu *et al.* 2006; Kao *et al.* 2012). Surficial runoff was permitted when the developed PWP on the slope surface changed to a positive value,

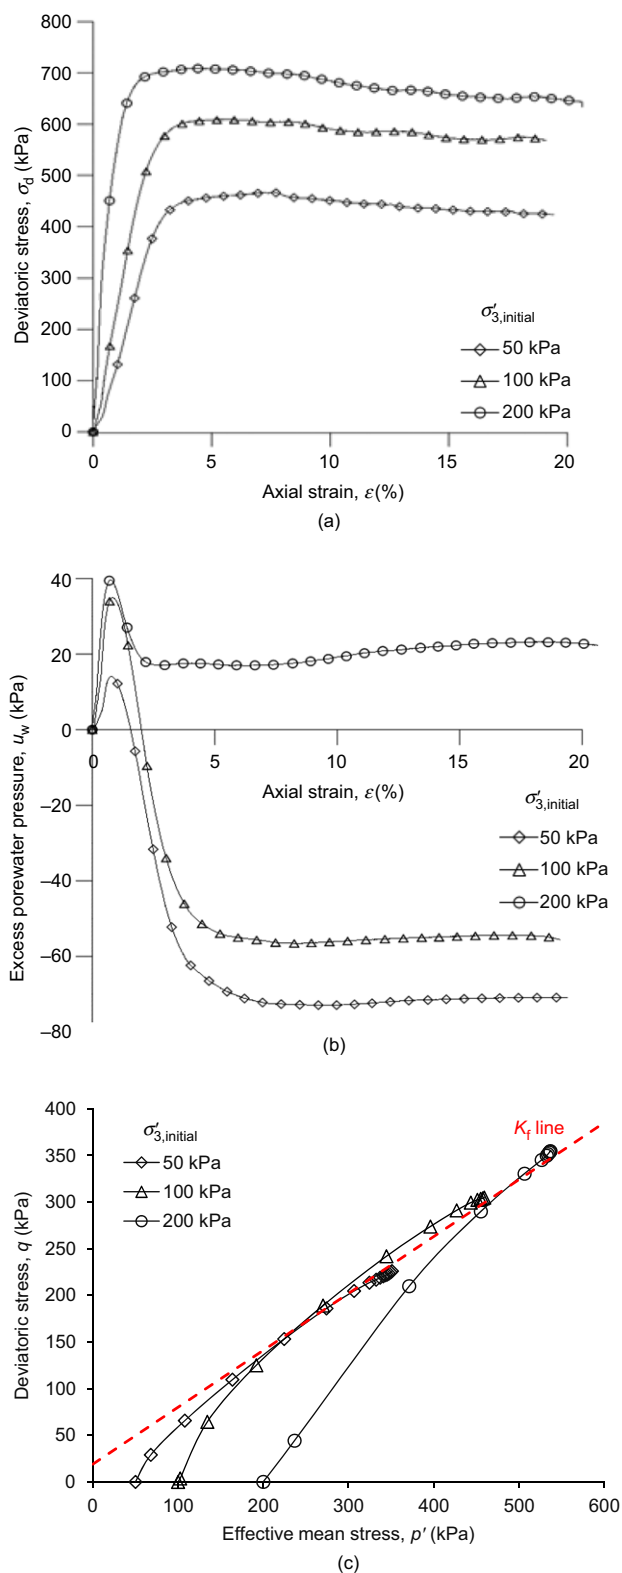
Figure 11. Triaxial CU test results of backfill: (a) stress-strain curve; (b) excess pore water pressure-strain curve; (c) effective stress path

The backfill soil specimens were prepared corresponding to the optimum moisture content $\omega_{opt} = 11.8\%$ and maximum dry unit weight $\gamma_{d,max} = 19.3 \text{ kN/m}^3$ determined from modified Proctor compaction tests. A series of consolidated undrained (CU) triaxial compression tests with pore pressure measurements according to ASTM D4767 was performed to determine the shear strength parameters of the backfill. Figure 11 demonstrates the CU test results and stress paths. On the basis of the test results, the peak shear strength properties of the backfill are the effective friction angle $\phi' = 37^\circ$ and the effective cohesion $c' = 23 \text{ kPa}$ and the residual ones are $\phi' = 37^\circ$ and $c' = 6 \text{ kPa}$ (Table 1). The substantial amount of effective cohesion is possibly due to the compaction-induced soil overconsolidation.

The analysis of backfill soil was performed using effective stress parameters under drained conditions. The undrained soil moduli obtained from the CU tests under different confining pressures (Figure 11a) were first converted to the drained soil modulus by using Equation 12, based on the elasticity theory.

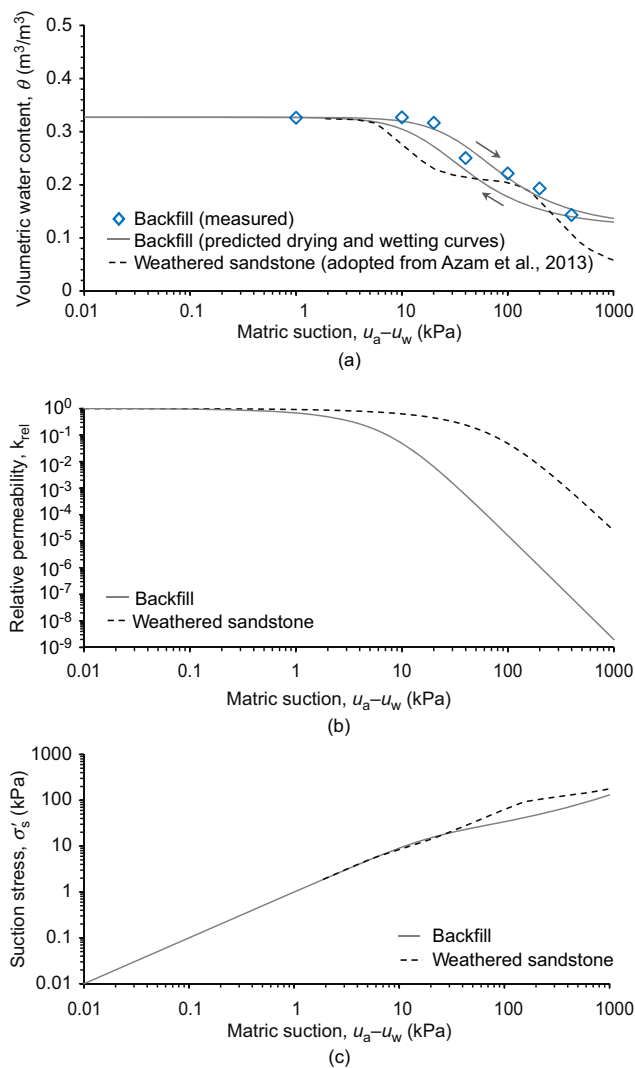
Figure 12. Hydraulic characteristics: (a) soil water characteristic curves (SWCCs); (b) hydraulic conductivity function curves (k -function); (c) suction stress characteristic curves (SSCCs)

Figure 12 illustrates the hydraulic characteristics of the backfill under unsaturated conditions. The drying soil–water characteristic curve (SWCC) of the backfill was obtained by applying various suction pressures to the soil specimens in the pressure plate test (ASTM D6836). The curve fitting parameters of the drying SWCC of the backfill were determined using the van Genuchten–Mualem model in Equation 4 as follows: $\alpha^d = 0.053 \text{ kPa}^{-1}$, $n^d = 1.78$, $\theta_s^d = 32.7\%$, and $\theta_r^d = 10\%$. By considering that infiltration is a wetting process, the Kool and Parker (1987) procedure was adopted

to approximate the parameters of the wetting curve. In Kool and Parker's procedure, α^d in the drying curve is multiplied by two to obtain α^w in the wetting curve (i.e. $\alpha^w = 2 \alpha^d$, superscript d and w refers to the main drying and wetting curves, respectively), whereas the other parameters, n , θ_s , and θ_r , remain unchanged. Thus, the fitting parameters for the wetting SWCC of the backfill were estimated as follows: $\alpha^w = 0.106 \text{ kPa}^{-1}$, $n^w = 1.78$, $\theta_s^w = 32.7\%$, and $\theta_r^w = 10\%$ (Table 3). As shown in Figure 12a, the backfill has an air entry value approximately in the range of 10–20 kPa. Figures 12b and 12c display the hydraulic conductivity function curve (k -function curve) and SSCC is calculated using Equations 4 and 8, respectively. Within the range of matric suction in this study (<100 kPa), the soil hydraulic conductivity decreases and suction stress increases as matric suction increases.

The hydraulic conductivity of the weathered sandstone was estimated to be $1 \times 10^{-6} \text{ m/s}$ according to the data of highly disturbed elastic sedimentary rocks in Taiwan reported by Ku *et al.* (2009). The SWCC of the weathered sandstone was adopted from Azam *et al.* (2013). As shown in Figure 12a, the SWCC of the weathered sandstone has a bimodal distribution. The first part of the SWCC has a lower air entry value (<10 kPa), which corresponds to the cracks and fissures of the parent rock, and the second part has a higher value ($\approx 300 \text{ kPa}$) that is associated with the matrix of the decomposed materials. Because the first part of the SWCC covers the range of matric suction in this study (<100 kPa), this part was employed to determine the fitting parameter values (Table 3) and then to develop the k -function curve and SSCC of the weathered sandstone (Figures 12b and 12c).

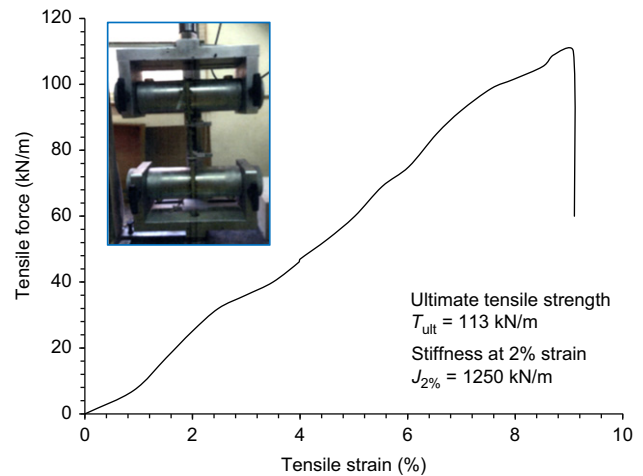
Figure 13. Reinforcement single rib tensile test

The geogrid specimen was retrieved from the failed slope in the field and tested by the single rib tensile method (ASTM D6637) to determine the long-term tensile strength of the geogrid after it was buried for almost 4 years. Figure 13 displays the tensile test results. The tensile strength of the retrieved geogrid is $T_{\text{ult}(\text{retrieved})} = 113 \text{ kN/m}$, and the secant stiffness at 2% strain is $J_{2\%} = 1250 \text{ kN/m}$. The long-term strength reduction factor is $\text{RF} = 1.3$ that is calculated by dividing $T_{\text{ult}(\text{retrieved})}$ by the ultimate tensile strength of the fresh (new) geogrid specimen $T_{\text{ult}(\text{fresh})}$ with a value of 150 kN/m. This RF value is considered very small compared with the total collective reduction value, typically in the range from 5 to 7 as suggested in the design guidelines, accounting for the negative impact from creep, durability, and installation damage. The reinforcement was modeled using a geogrid element with an axial stiffness and tensile strength on the basis of the tensile test results. The soil-reinforcement interface was assumed to be fully bounded in the numerical model, as the primary

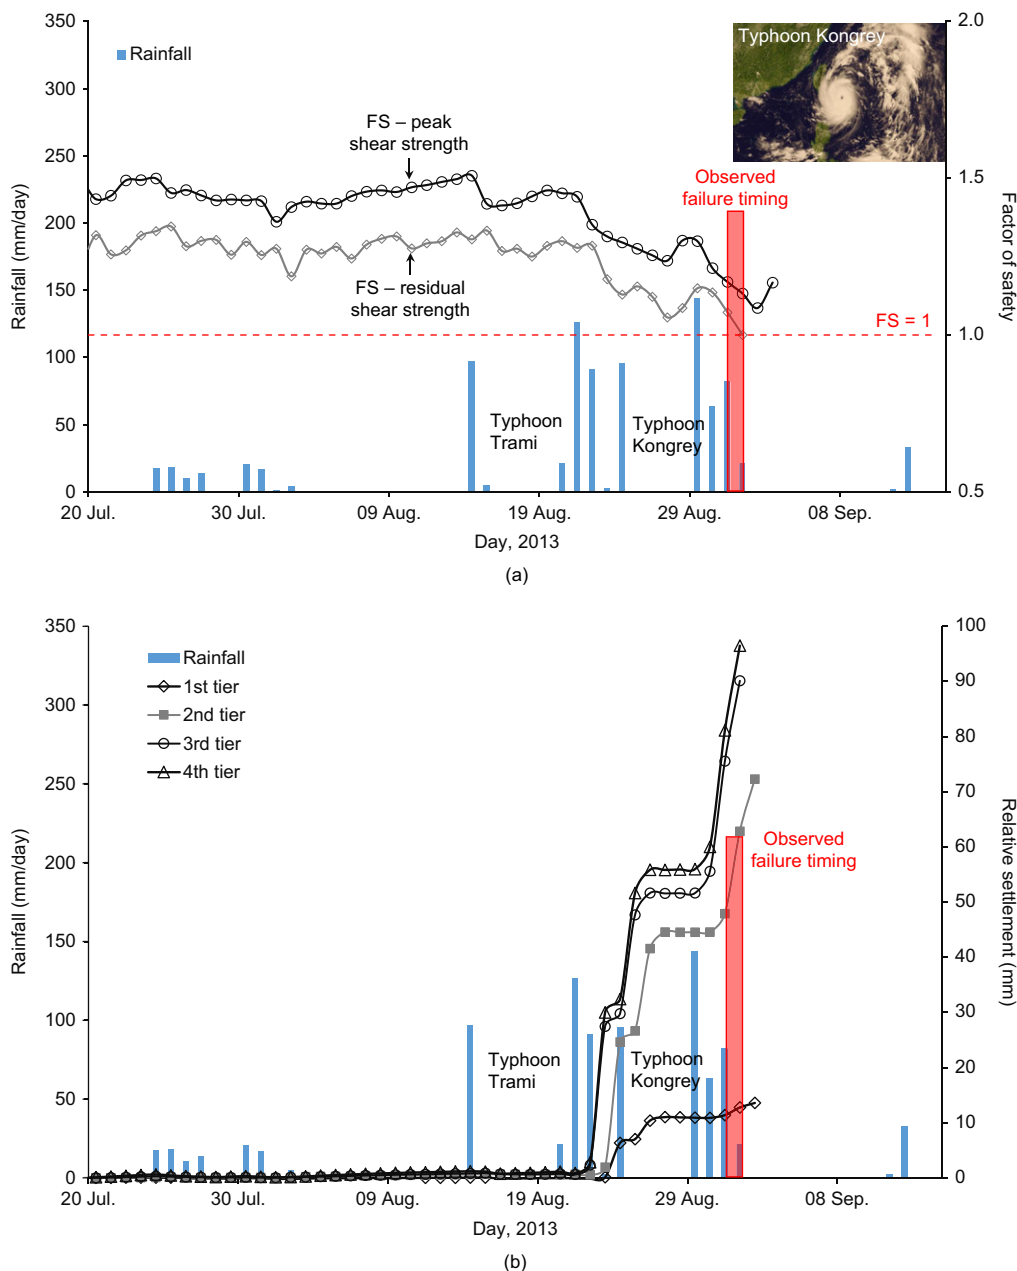
Figure 14. Numerical results: (a) factor of safety; (b) slope settlement

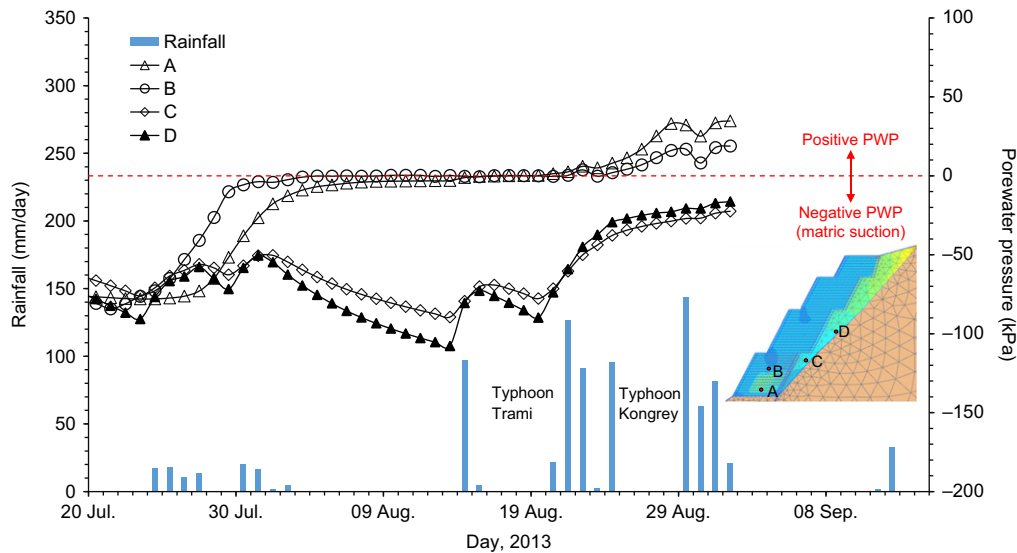
Figure 15. Development of porewater pressure at various locations

Figure 15 displays the development of PWP at various locations. The PWP within the backfill (points A and B in Figure 15) increased to 0 kPa (saturated state) after

the rainfall at the end of July. Owing to the low permeability of the backfill, the PWP could not dissipate effectively, and soil remained fully saturated even during dry days when the evapotranspiration was modeled. The PWP within the weathered sandstone (points C and D in Figure 15) increased during the rainfall at the end of July and then decreased during the dry days. Because the weathered sandstone has a k_s value of one order higher than that of the backfill, the responses of PWPs in the weathered sandstone to weather conditions are much faster than those in the backfill. During the two major typhoon events, the PWPs accumulated and became positive within the backfill, and the PWP within the weathered sandstone gradually increased to a low suction value.

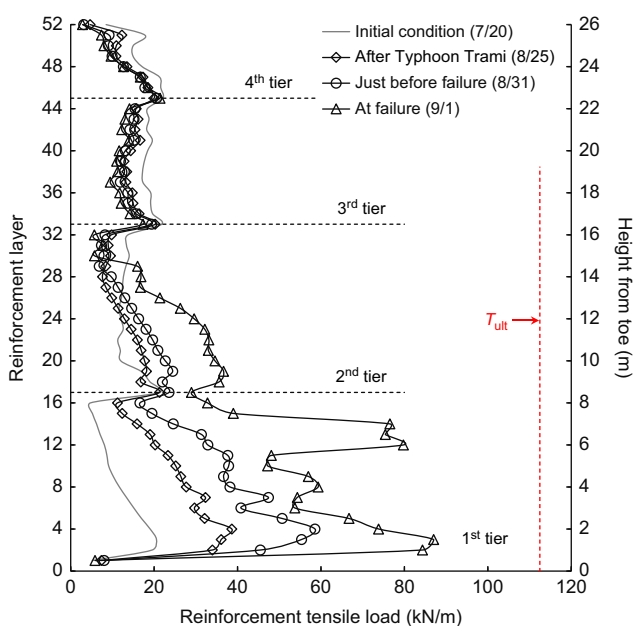
Figure 18. Maximum reinforcement tensile load profile

prime interest. Figure 17 illustrates the mobilization and distribution of reinforcement tensile loads along the reinforcement layer at different timings. Figure 18 displays the profile of the maximum mobilized reinforcement load with the slope height. Because of the modeling of stage construction and initial hydrological conditions, the reinforcement loads at the bottom layer of each tier were mobilized at approximately 20 kN/m in the initial

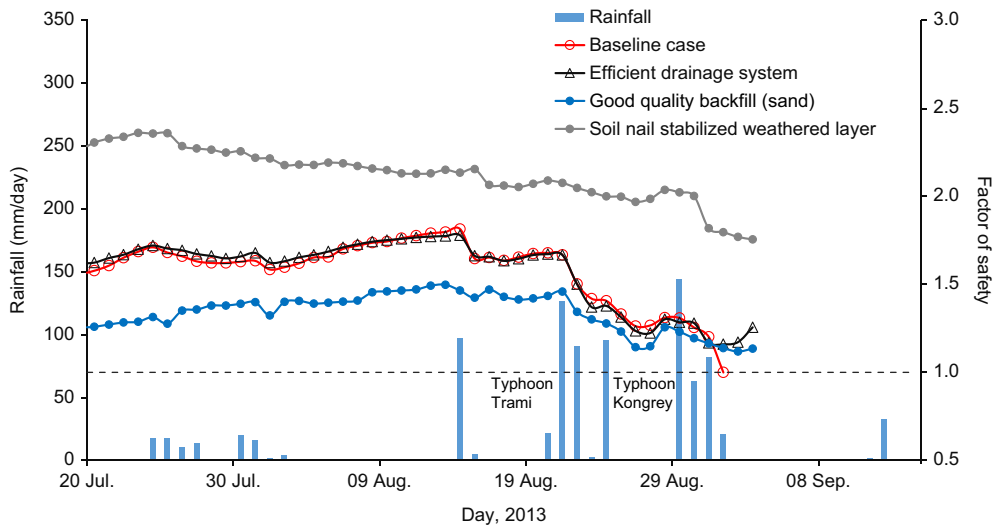
Figure 20. Predicted FS for remedial measure cases

Case no.	Description	Minimum FS
Baseline case	Failure analysis	1.00
RM1	Soil nail stabilized weathered layer	1.57
RM2	Efficient drainage system	1.09
RM3	Good quality backfill (sand)	1.07

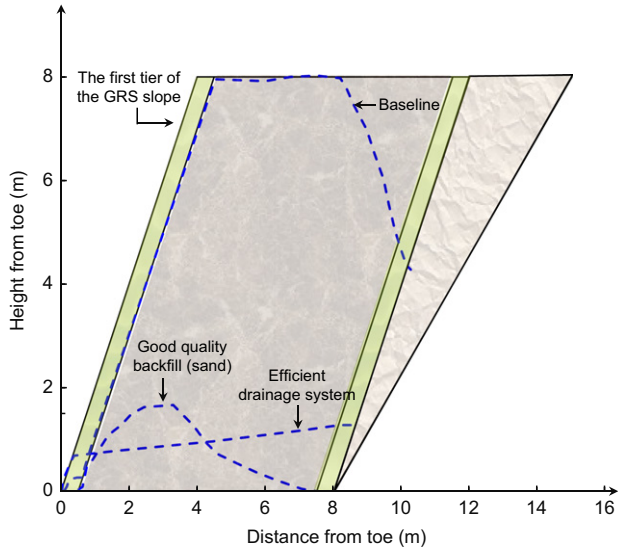
Figure 21. Comparison of phreatic surfaces in the first tier
