Geotextiles and Geomembranes

Performance of geosynthetic-reinforced soil foundations across a normal fault

Kuo-Hsin Yang^{a,*}, Jung Chiang^a, Chao-Wei Lai^b, Jie Han^c, Ming-Lang Lin^a

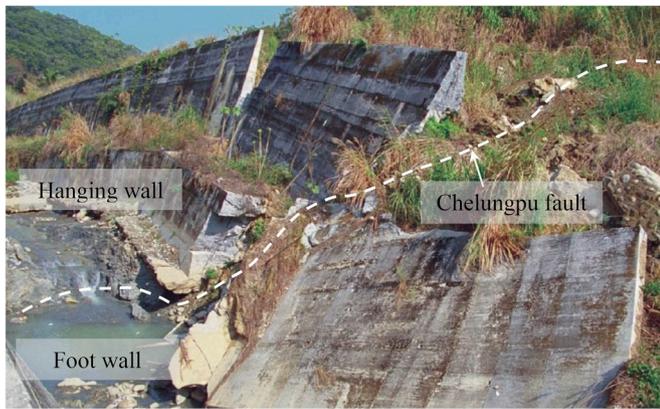
Fig. 1. Collapse of a gravity type retaining wall that straddled an active fault during the Chi-Chi earthquake.

occurs. Previous failure experiences had shown that gravity-type retaining walls were too rigid to withstand large differential settlement induced by fault displacements (Fig. 1). The final decision of this highway extension project was, therefore, to design a ductile highway embankment to traverse the surface fault rupture zone using geosynthetic-reinforced soil (GRS) structures in lieu of conventional concrete retaining walls. The GRS structure consists of a GRS wall and an underlying GRS foundation (Fig. 2). The GRS foundation was adopted to enhance the bearing capacity of the foundation soil and reduce the extent of fault-induced angular distortion to an acceptable level. The GRS wall was constructed to accommodate the differential settlement at the ground surface and maintain the stability and serviceability of the highway embankment. The focus of this study is to investigate the effect of the GRS foundation on reducing the fault-induced angular distortion at the ground surface.

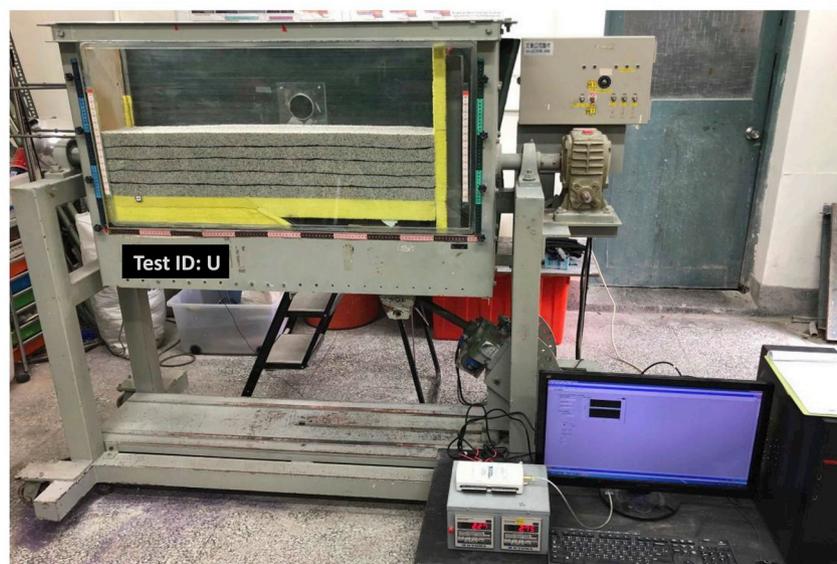
Fig. 3. The sandbox and test setup: (a) illustration; (b) panorama.

The reduced model tests on unreinforced and reinforced soil foundations were conducted using a sandbox in the geotechnical research laboratory at National Taiwan University. Fig. 3 presents an illustration and overview image of the sandbox and test setup of the reduced-scale model test. The dimensions of the sandbox were $100 \times 20 \times 60$ cm (length \times width \times height). Transparent Plexiglas walls were installed on two longitudinal (i.e., front and back) sides of the sandbox for visual observation of soil deformation during the test. To ensure that the soil model was tested under a plane strain condition, a thin plastic sheet

with lubricant was applied at the internal face of each Plexiglas wall to minimize side friction at the soil–wall interface. The bottom of the sandbox consisted of a movable hanging wall and a fixed footwall. Normal or reverse fault displacement was generated by moving the hanging wall upward or downward by using a driving motor installed underneath the sandbox. This study focuses on the test results of a foundation model subjected to normal fault displacement. The initial location of the tip of the bedrock fault was $x = 54$ cm from the left boundary. The fault dip angle was set to be 60° in the present study.
