CASE STUDY OF A REINFORCED SOIL SLOPE WITH MARGINAL BACKFILL AS A DETENTION POND IN FLOOD CONTROL

Key words: Geosynthetic-reinforced soil slope, waterfront retaining system, flood detention pond, marginal backfill, sustainability.

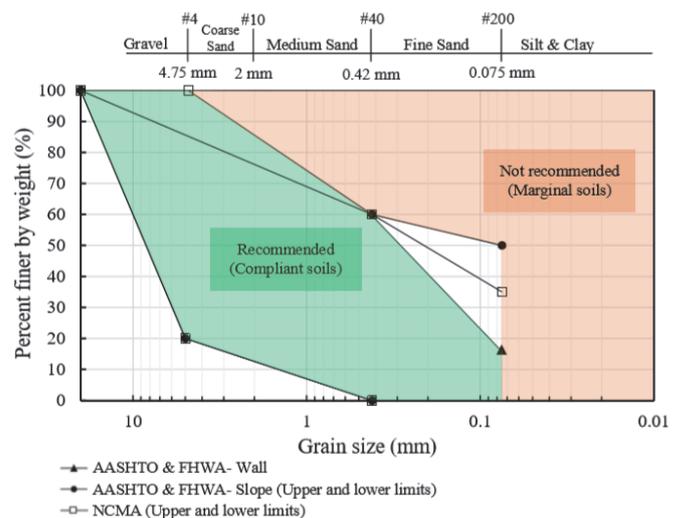
Fig. 1 Grain size distribution of backfill in GRS structures as recommended by design guidelines

and used in flood basin environments. Figure 1 displays the gradation limits for backfill suggested in the design guidelines (Elias *et al.* 2001; AASHTO 2002; Berg *et al.* 2009). Besides, the plasticity index (PI) of the backfill is specified ($PI \leq 6$ and 20 for walls and slopes, respectively). The soil that satisfies the grain size recommendations specified in the design guidelines (*i.e.*, granular soil) is considered good quality backfill. In contrast, the soil that does not meet the grain size recommendations (*i.e.*, cohesive soil) is referred to as marginal backfill. Marginal backfill was adopted primarily because of economic and sustainability concerns, as explained in later sections.

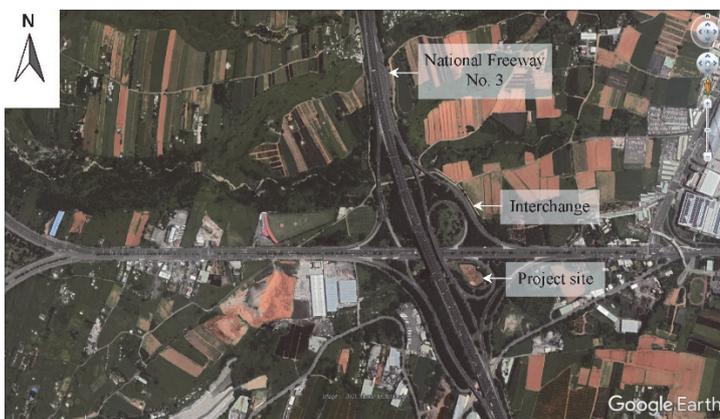
Fig. 2 Satellite image of the project site (from Google Earth)

The detention pond project is located within the northern ramp of Shalu Interchange on National Freeway No. 3 in the west of Taichung city, Taiwan. Figure 2 presents a satellite image of the project site. The new detention pond was constructed to replace the original one with insufficient storage capacity. Figure 3 presents an aerial photo of the original detention pond. The dimensions of the original detention pond are approximately 25 m × 15 m × 3 m (length × width × depth). Because of the insufficient storage capacity (only 1,125 m³), the surface runoff collected in the catchment area (457,000 m²) frequently caused the original flood detention pond to overflow, consequently causing flooding in the downstream Shalu area. Based on the hydrological analysis, the new required detention capacity is 20,632 m³, 18.3 times larger than the original one. This capacity for the proposed enlarged and deepened detention pond was achieved by digging down from the original ground level. Figure 4 presents photos of the new heart-shaped flood detention pond. The proposed detention pond is meant to collect stormwater runoff from the catchment area, store it to prevent peak discharge, and then slowly discharge it to the downstream creek to resolve the flooding problem in the Shalu area. The delay time generated by the detention has been estimated to be 188 minutes from the peak.

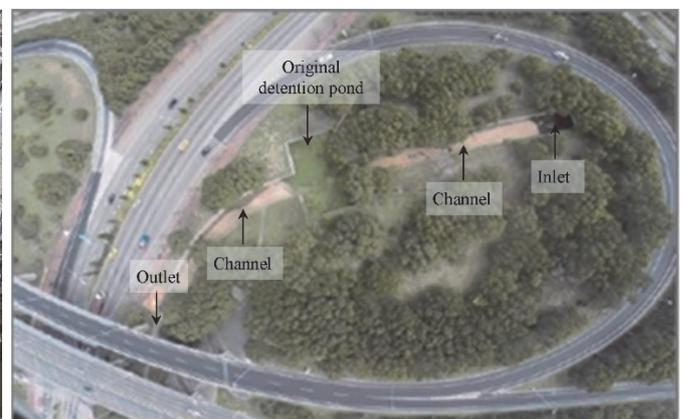
Fig. 3 Aerial photo of the original detention pond

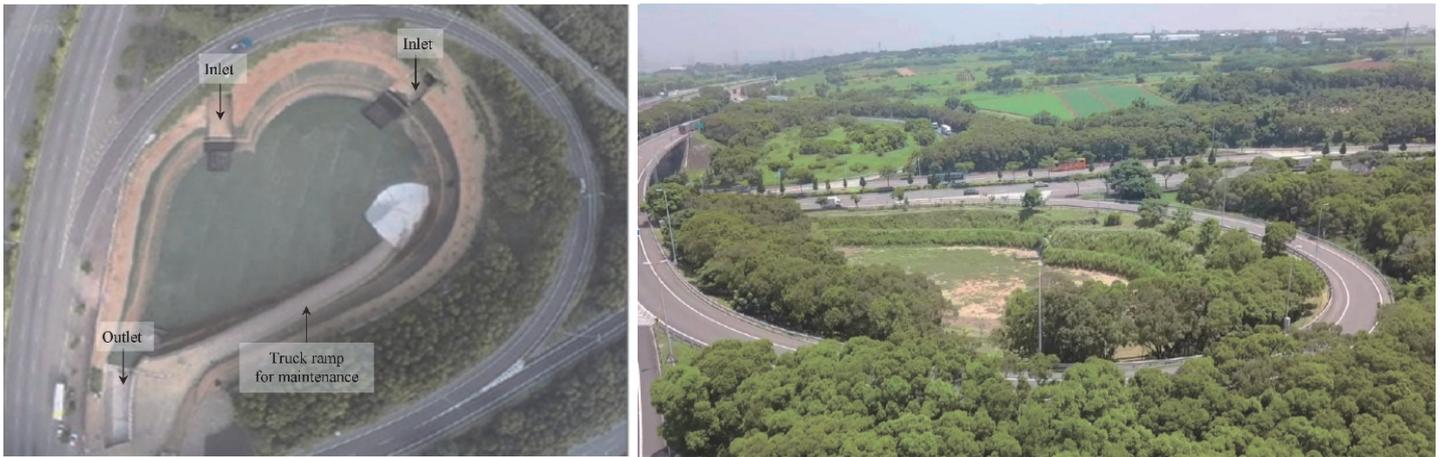
(a) Aerial photo

(b) Panorama

Fig. 4 New heart-shaped detention pond

The flood detention pond was constructed by excavating the ground to approximately 10 m (Figs. 4 and 5). The total excavation area was approximate 6,000 m², and the detention capacity was 20,632 m³. The detention pond has two inlets and two outlets. The two inlets discharge the stormwater runoff from the catchment area into the detention pond (Fig. 4). The two outlets are in the same position but at different elevations (Fig. 9). The upper outlet, located 5.75 m above the base of the detention pond, discharges the overflow of the flood into an open channel, thereby controlling the maximum water level in the detention pond at this elevation. The upper outlet functions as an emergency spillway to maintain the safety of the detention pond during storms. The lower outlet, located 0.75 m above the base, consists of three 100-cm-diameter drainage pipes. The lower outlet discharges the remaining floodwater in the detention pond and keeps the pond dry after storms.

The RSS and flood detention basin construction was completed in less than 5 months, and the project was completed in November 2015. Figure 4 displays the finished project. Since the project was completed, the site has experienced many typhoon and storm events. Table 4 presents the rainfall data in the project area caused by these events. Figure 20 displays the performance of the GRS detention pond during a storm event. As expected, muddy water from upstream was temporarily deposited in the detention basin and then diverted smoothly to the downstream discharge area. The RSS used in flood basin environments has been thoroughly tested, and it exhibited neither damage nor observable deformation.

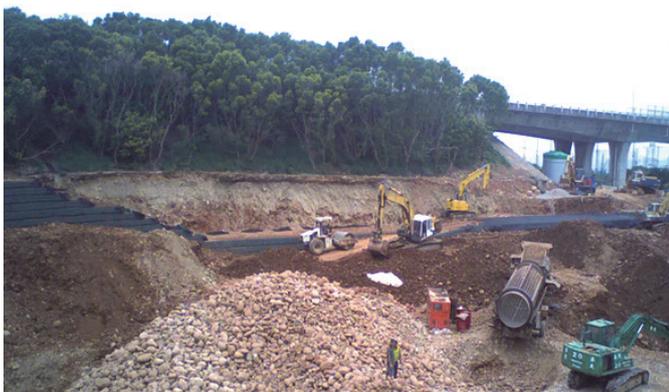
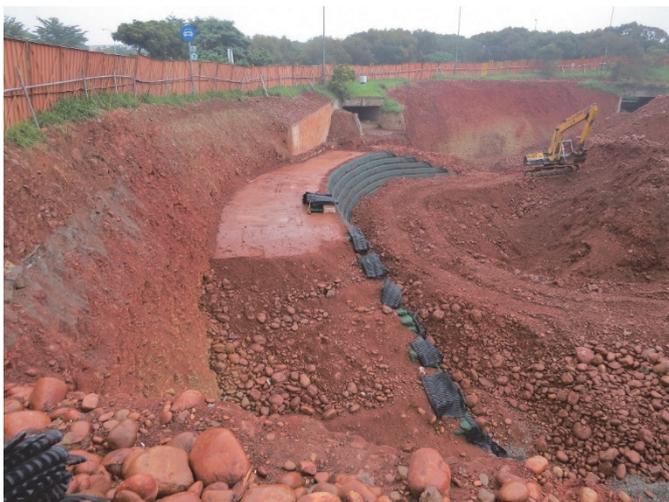
(a) Cobble and gravel are screened and piled aside

(b) Close view

Fig. 5 Typical onsite materials of the laterite terrace deposits exposed during construction excavation

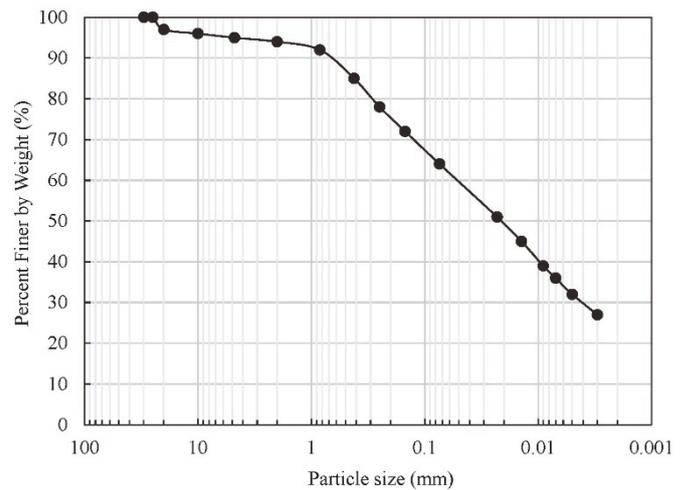
Fig. 6 Grain size distribution curve of the red clayey soil

The geotechnical investigation results indicated that the standard penetration test (SPT) values of the subsurface soil were higher than 50 (*i.e.*, $SPT-N \geq 50$). The high SPT-N values are attributed to the presence of cobble and gravel. Groundwater was not observed under normal conditions, indicating that the groundwater is deeper than the borehole depth (~15 m). However, because the project is located in the slope area, with an average 10° downward gradient to the west, the groundwater level could rise because of seepage accumulated from the upland during storm events. Figure 6 shows the grain size distribution curve for the red clayey soil, containing 35% sand, 32% silt, and 33% clay. The behavior of the fine materials is controlled by the red clay, which has low permeability. The red clayey material has a liquid limit (LL) = 27 and a plasticity index (PI) = 12, as indicated by Atterberg limit tests, and is classified as low-plasticity clay (CL) according to the Unified Soil Classification System.

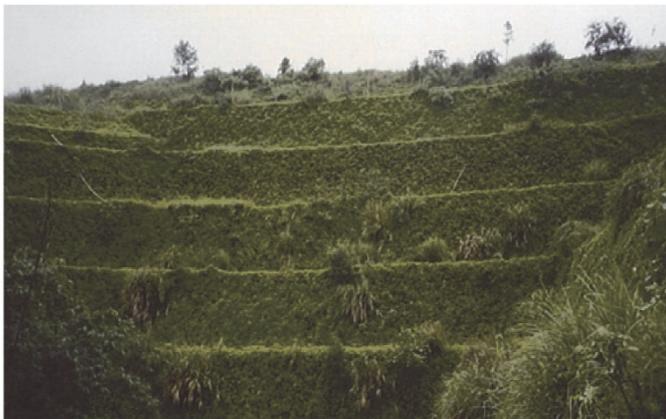
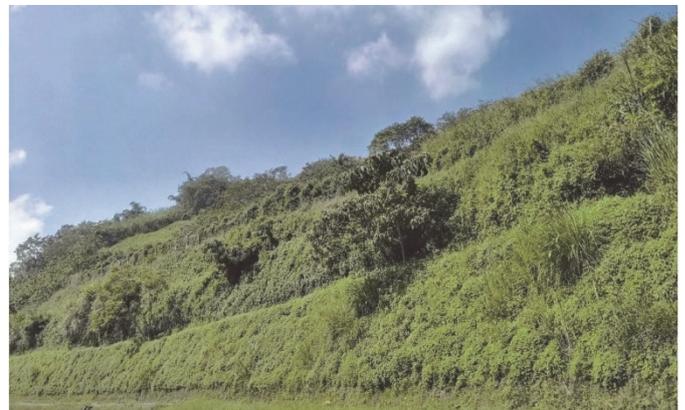
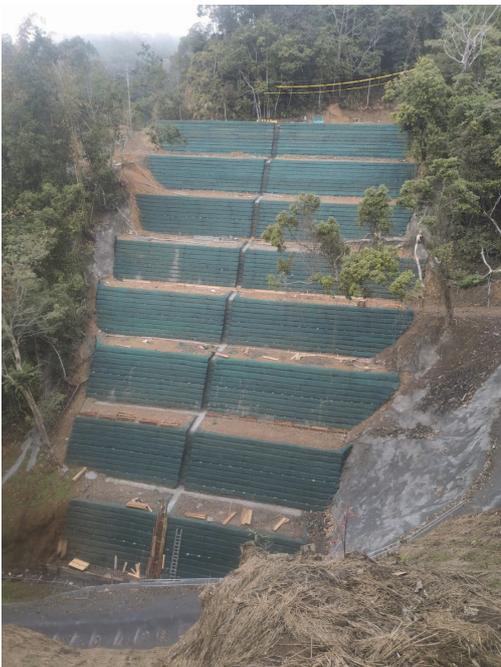
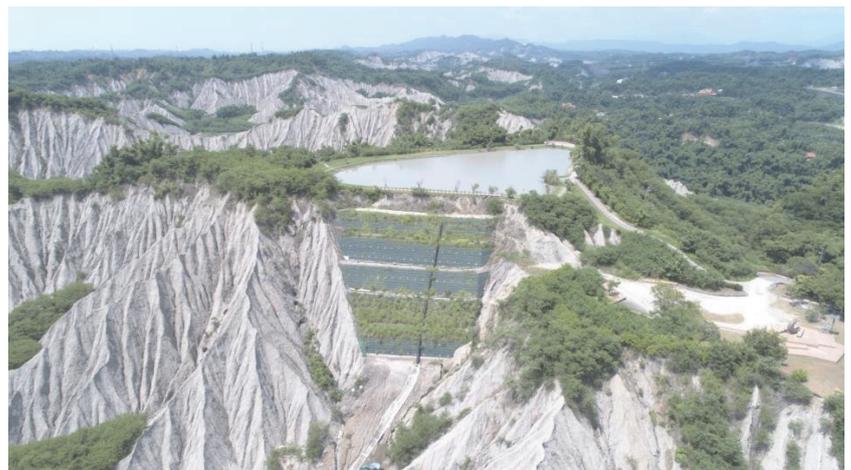
(a) A 35 m RSS of a residential community for slope stabilization, once the highest wall in the world in 1993

(b) A 30 m RSS at National Chi Nan University for slope stabilization

(c) A 40 m RSS near Sun Moon Lake for landslide remediation

(d) A 25 m RSS in Moon World for mudstone protection

Fig. 7 Geosynthetic-reinforced soil slope with onsite cohesive backfill in Taiwan

alternate backfill when granular backfill was unavailable or too expensive or when borrowed materials may have had a negative environmental impact. Figure 7 presents four cases of RSS with on-site cohesive backfill. Figure 7(a) displays a 35-m RSS in a residential community used for slope stabilization. In 1993, it was the highest GRS structure in the world. Figure 7(b) displays a 30-m RSS at National Chi Nan University used for slope stabilization. Chou *et al.* (2020) conducted a detailed investigation of the sustainable renovation of this RSS. Figure 7(c) presents a 40-m RSS near Sun Moon Lake used for landslide remediation. Figure 7d displays a 25-m RSS in Tianliao Moon World used for slope protection and to prevent the breach of the uphill lake due to severe mudstone erosion. Because these RSSs were all backfilled with marginal soil, they were carefully designed and constructed with special attention to the drainage system. The evaluation of the slope stability considered the effect of PWP. These aspects are discussed in detail in later sections.

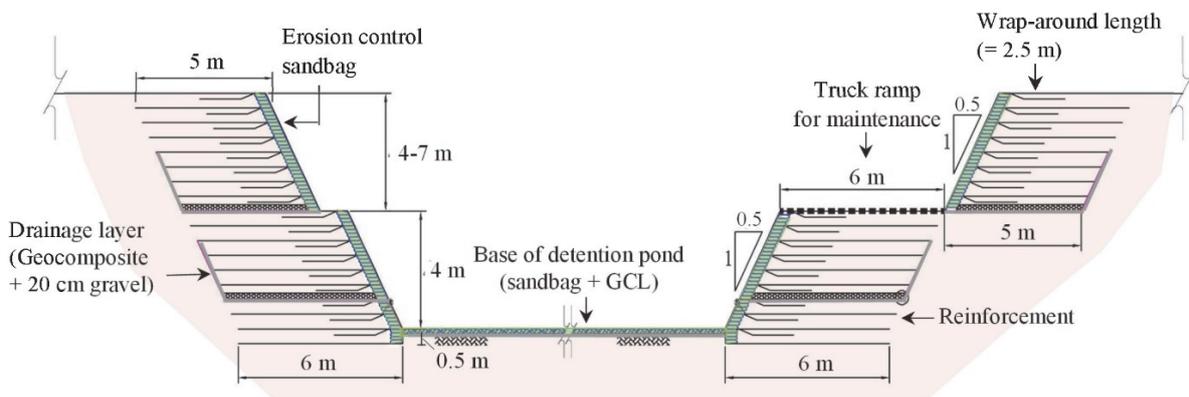
Fig. 8 A typical cross-section of the geosynthetic-reinforced soil slope across the basin of the detention pond

was constructed in two tiers, with a slope ratio of 1 (V):0.5 (H) for each tier. Figure 8 illustrates a cross-section of the RSS across the basin of the detention pond. A RC wall with this design configuration could cost approximately US\$478,200 more than would the RSS. Christopher (2014) also indicated that using GRS structures can reduce costs by 25% ~ 50% compared with the expense of RC structures and that using on-site marginal soil can reduce total wall costs by 20% ~ 30%. Table 2 lists the carbon footprint calculation of the RSS and RC wall for this project. The vegetated RSS used in this project could reduce CO₂ emission by an estimated 1213.92 tons compared with the RC wall.

An RSS was constructed to stabilize the excavated slope of the detention pond basin. The total length of the RSS is 285 m, and it surrounds the detention pond basin. Figure 8 presents the configuration of the RSS. The RSS is 8 to 11 m high and comprises two tiers. Each tier has a height ranging from 4 to 7 m, depending on the on-site topography, and the offset distance between the two tiers is 1 to 6 m. The significant offset distance (6 m) enables the RSS to serve as a downslope ramp for trucks, thus providing access for long-term maintenance (*i.e.*, dredging the deposited sediments as shown in Fig. 9). The slope face inclination ratio is 0.5 (H):1 (V) (~63°). The reinforcement is polyester (PET) geogrid, with an ultimate tensile strength of $T_{ult} = 180$ kN/m, determined through a single rib tensile test (ASTM D6637) (Fig. 10). The geogrid layers are 5 and 6 m long for the upper and lower tiers, respectively, spaced 0.5 m apart vertically. The slope face is formed by the geogrid wrapping around the sandbags (Fig. 11(a)). The length of the wrap-around (or secondary) reinforcement is 2.5 m. To prevent slack in the loopback section, the contractor pre-tensioned the reinforcement by pulling the wrap-around reinforcement tightly with a backhoe during construction. The sandbag for erosion control is made of high-durability erosion control mate. The size of the openings in the sandbag is less than 1.5 mm to prevent the erosion of the backfill material. The slope was vegetated through hydroseeding to create a green and natural appearance.

Regarding the design of the drainage system, a drainage chimney was installed in each tier of the RSS (Fig. 8). The drainage layer consists of a geocomposite with 20 cm of gravel soil. The gravel was placed directly on top of the geocomposite and geogrid, a method that has been proven to accelerate PWP dissipation effectively. It increases the drainage capacity of the soil–geotextile system (Raisinghani and Viswanadham 2010; Thuo et al. 2015; Yang et al. 2018). Fine-grain soils also reduce surficial intrusion and long-term clogging in geotextiles (Lin and Yang 2014). Besides, it increases pullout resistance (Abdi and Zandieh 2014) and enhances reinforced soil strength and deformation characteristics by strengthening the soil–reinforcement interface (Unnikrishnan et al. 2002; Abdi et al. 2009; Yang et al. 2016, 2018). Finally, a blanket of geosynthetic clay liner (GCL), functioning as a hydraulic barrier, was placed at the base of the detention pond to prevent water leakage and mitigate the potential of uplift pressure acting on the adjacent highway foundation during flooding (Fig. 11(c)). The GCL was carefully installed and covered with sandbags to prevent penetration and breakage due to any sharp object or debris in the flood discharge.

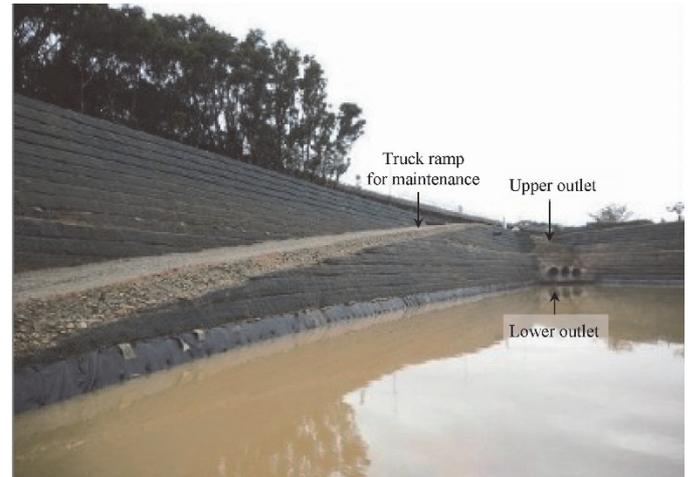
Fig. 9 Detention pond with outlets, reinforced soil slope and downslope ramp for truck access

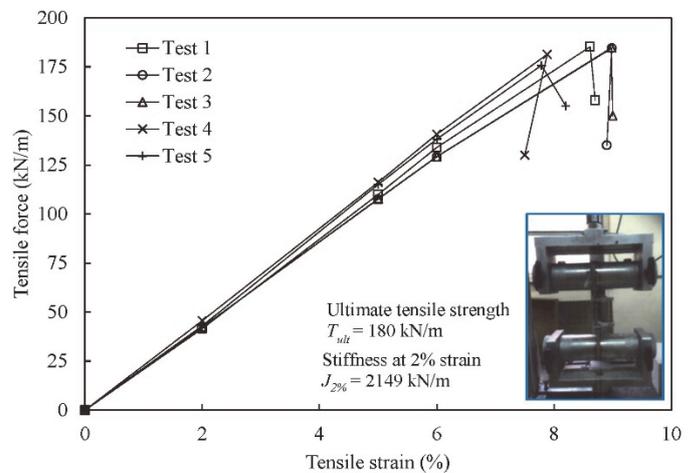
Fig. 10 Reinforcement single rib tensile test

The reinforcement had an ultimate tensile strength of $T_{ult} = 180$ kN/m, obtained through a single rib tensile test (ASTM D6637) as shown in Fig. 10. Because the marginal soil was used as backfill, according to the suggestions in the design guidelines (Berg *et al.* 2009; Elias *et al.* 2001), a high reduction factor ($RD = 7$) should be applied to account for the long-term strength reduction due to installation damage, durability, and creep. Therefore, the long-term reinforcement tensile strength used in the numerical analyses was $T_{al} = 25.7$ kN/m ($= 180/7$). The interface efficiency factor was adopted to calculate the soil-geogrid interface shear strength parameters (c'_a and δ') as follows:

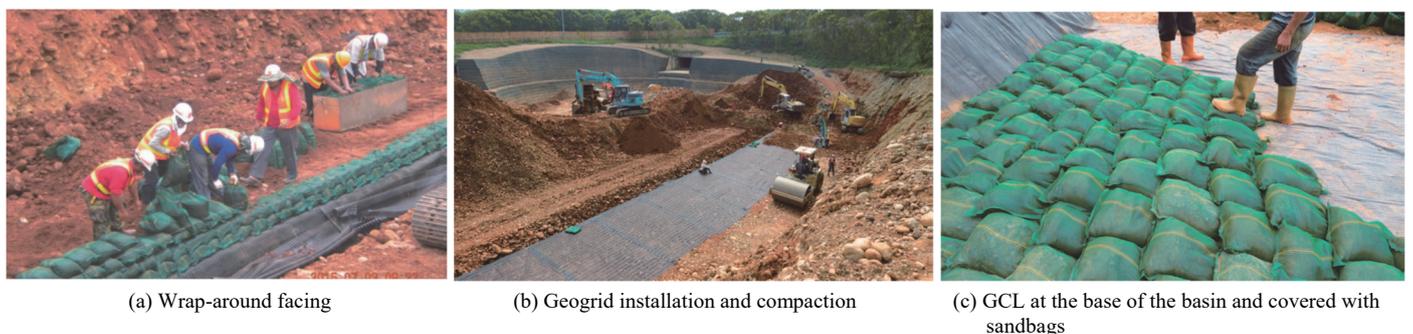
Fig. 11 Construction details

Compaction of the marginal backfill is essential. For field compaction, the soil was compacted using drum rollers (Fig. 11(b)) on every 30-cm soil lift, and the soil was required to reach 90% of maximum dry unit weight $\gamma_{d,max}$ according to the results of the modified Proctor compaction test. The backfill within 1 m of

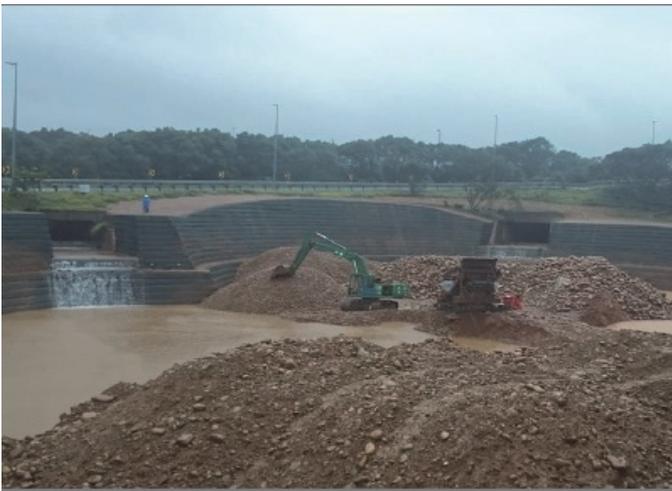
Fig. 12 The site suffered by Typhoon Dujuan during construction

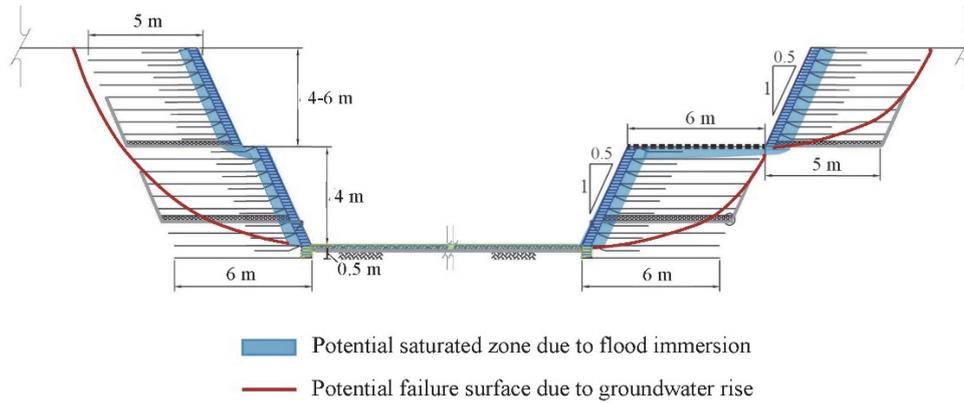
Fig. 13 Illustration of the potential saturated zone due to flood immersion and the potential failure surface due to groundwater rise

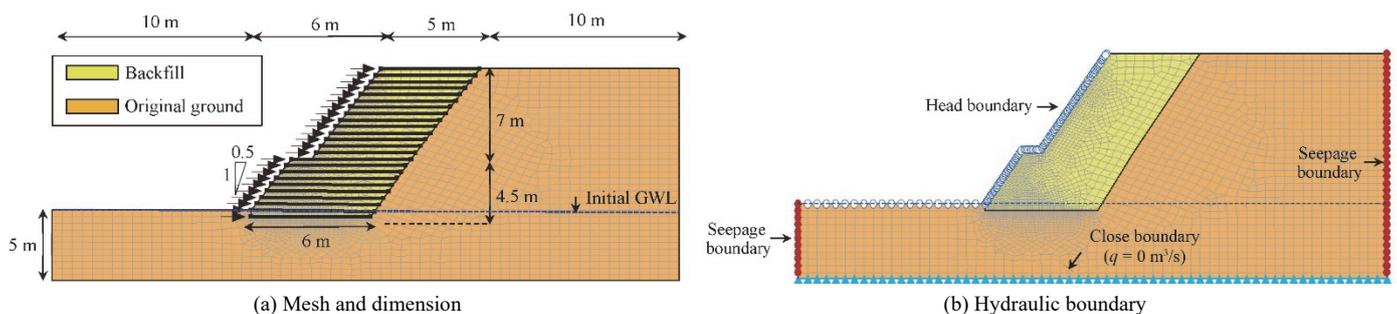
Fig. 14 Numerical model

Figure 14 displays the numerical model and hydraulic boundary conditions. The numerical model was established in compliance with the configuration of the designed RSS, as shown on the left side of Fig. 8. The RSS model consists of 3,797 four-node quadrilateral elements. Fine mesh with a global height of approximately 0.1 m was designated for areas close to the slope-face that may be affected by flood seepage. A head boundary was prescribed for the slope-face (0 to 6 m above the basin base). Seepage boundaries were assigned to the right and left sides of the model to simulate the change in groundwater level during flooding. A closed (zero-flux) boundary was set on the bottom of the model. The potential seepage face review option was selected for the slope face, which can automatically switch the head boundary to a flux boundary when the water level decreases. This option also allows for the development of outward seepage force in the RSS to simulate rapid drawdown.

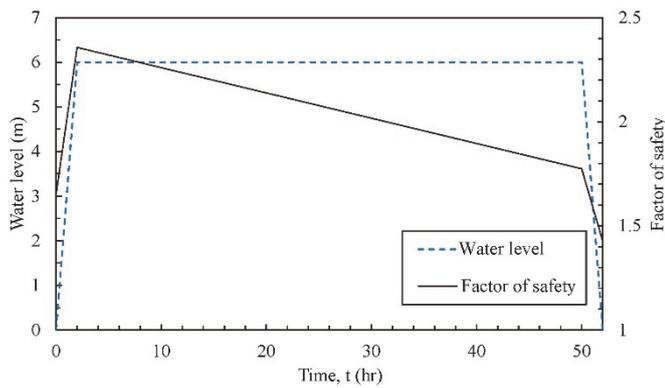
Fig. 15 Time history of water level and variation of FS with time

Figure 15 shows a flood history applied to the face of the RSS. The flood history was statistically derived using hydrological data from previous typhoons and storms (Table 4). The total flood period was 52 hours, and the water level on the slope face increased from the initial groundwater level to the maximum (6 m) during the first 2 hours. The water level remained maximum for 48 hours and returned to the initial groundwater level in the final 2 hours. The location of the initial groundwater level was assumed to be the bottom of the basin.

Figure 15 displays the change in FS over time, and Fig. 18 presents the numerical results (*i.e.*, FS and potential failure surface) at the selected times. The numerical results indicated that FS could change over time but that the RSS remained stable ($FS > 1$) throughout the flood event. At initial condition $t = 0$ h, FS was equal to 1.65 (Fig. 18(a)). When the water level was at maximum ($t = 0-2$ h), FS increased to 2.35 due to the imbalance in PWP between the front and the rear of the RSS (Fig. 18(b)). As shown in Fig. 18(b), the PWP in front of the RSS was higher than that at the rear of the RSS. This difference in pressure results in a resultant inward force acting on the slope face as a stabilized force, thereby increasing system stability. When the water level remained at maximum for two days ($t = 2-50$ h), the FS decreased to 1.77 as the seepage infiltration proceeded (Fig. 18(c)). Although the phreatic surface in the original ground rose to the maximum water level during this period, the system stability remained satisfactory because the cobble and gravel in the original ground layer had high soil shear strength. When the water level dropped to the initial level ($t = 50-52$ h), the FS decreased to 1.42, the minimum FS value during the flood event. The decrease in FS was caused by the imbalance in PWP between the front and the rear of the RSS (Fig. 18(d)). During this period, the water level in front of the RSS drained completely, whereas the PWP at the rear of the RSS dissipated relatively slowly. This difference in pressure causes an outward seepage force to act as a driving force, therefore decreasing system stability.

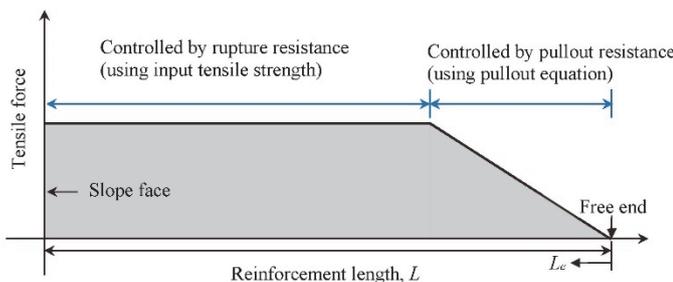
Fig. 16 Schematic of input tensile force distribution along reinforcement length

where P_r is the pullout resistance; $R_c (= 2)$ is the coverage ratio (or surface area factor), considering both the top and bottom surfaces of reinforcement. Besides, L_e is the horizontal distance to the free end of reinforcement; c'_a and δ' are the interface cohesion and friction angle, respectively, σ'_v is the effective overburden pressure on the reinforcement layer. The pullout resistance of the reinforcement increased linearly from zero at the free end of the reinforcement to a value equal to the input reinforcement tensile strength (Fig. 16).

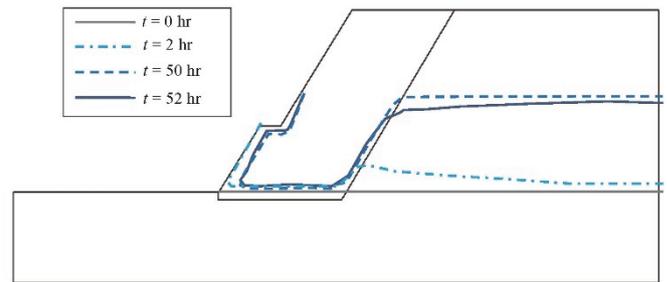
Fig. 17 Variation of phreatic surface with time

Figure 17 presents the variation in the phreatic surface over time. The numerical results indicated that the maximum seepage infiltration distance in the reinforced zone was limited to approximately 60 cm because of the low permeability of the compacted red clay. Therefore, the area that could be saturated by flood immersion was limited to within 1 m of the slope face during the applied flood event. The numerical results verified the discussion on the safety of the RSS in Section 2.5. Notably, the variation in the phreatic surface in the original ground layer (*i.e.*, the soil layer behind the RSS) was associated with the changes in water level. The difference between the changes in the phreatic surface in the reinforced zone and the original ground could be attributed to the significant difference in permeability.

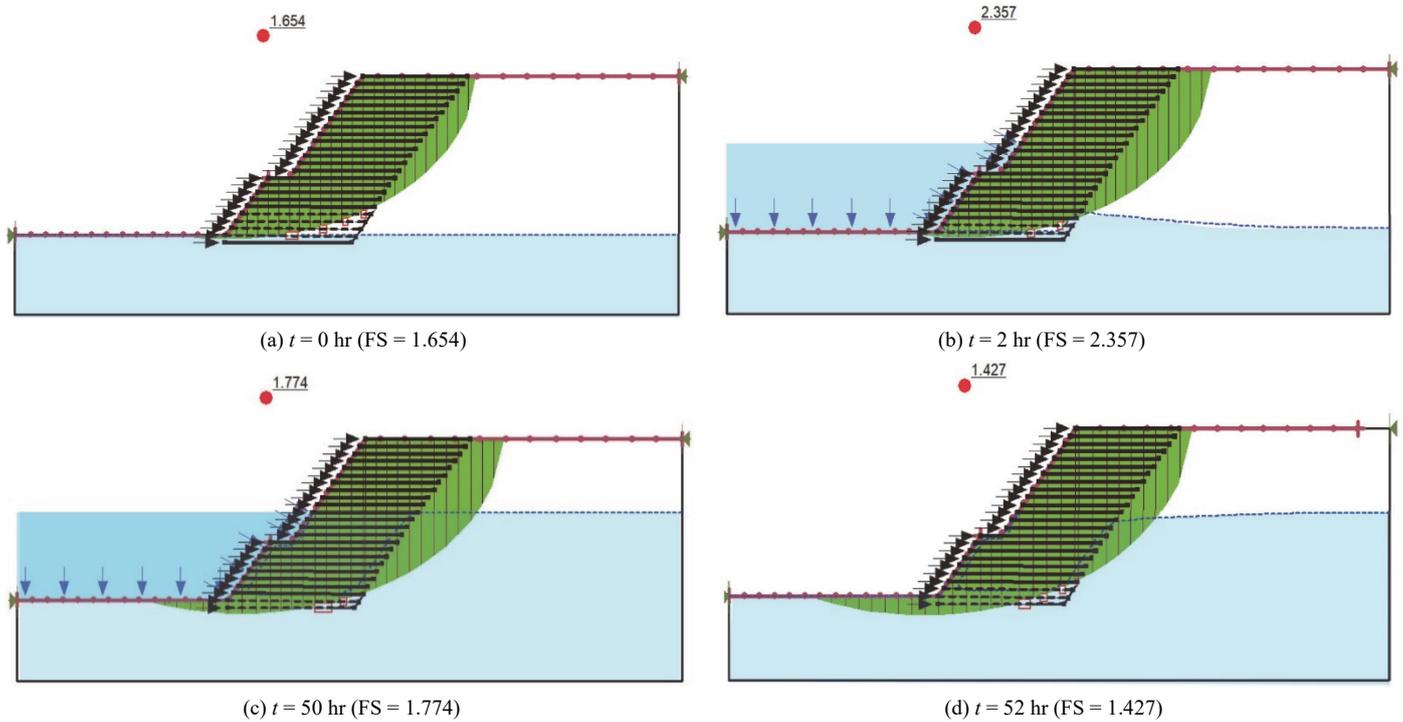
Fig. 18 Potential failure surface and FS at different timing

The potential failure surface exhibited a compound failure mode in which the failure surface partially cut through the reinforced zone and passed through the original ground layer. Despite the change in FS over time, the potential failure surface remained at a similar location throughout the flood event. The compound failure model has been reported as common failure modes for GRS

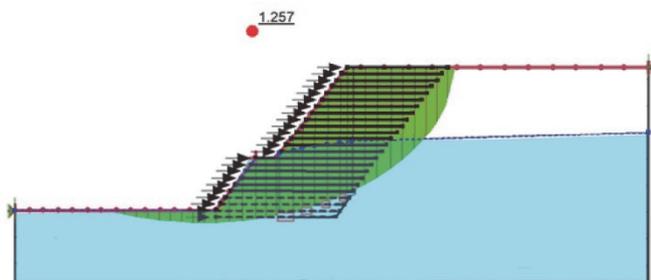
Fig. 19 Potential failure surface and FS at the assumed most critical conditions (FS = 1.257 at high groundwater level and rapid drawdown conditions)

In addition to these analyses, a hypothetical case involving a high phreatic surface in the reinforced zones and no external water in the detention pond was analyzed (*i.e.*, drawdown conditions; Fig. 19). In reality, this hypothetical case is unlikely to occur because the numerical results revealed that the water level in the detention pond must remain at a maximum for approximately 250 days for the phreatic surface in the reinforced zone to rise to a high level. However, no typhoon or storm event on record in Taiwanese meteorological data has lasted for such a long period. Nevertheless, this hypothetical case was analyzed to evaluate the stability of the RSS under the most extreme conditions. The numerical results indicated that the RSS had adequate FS ($= 1.25$) under these conditions (Fig. 19). An FS value of 1.1 is required in local codes for retaining walls or engineered slopes under storm conditions.

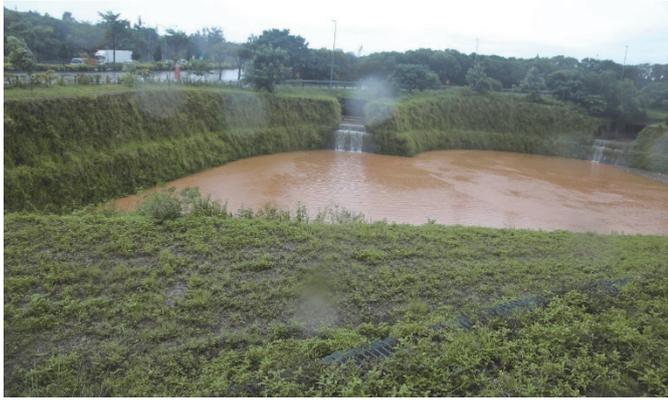
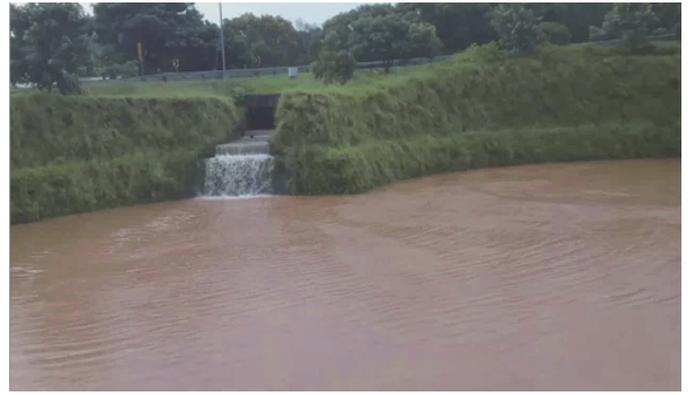
(a) Maintain stability under high water level

(b) Muddy water from the upstream watershed was temporarily deposited in the detention pond

Fig. 20 Performance of the GRS detention pond during a storm event

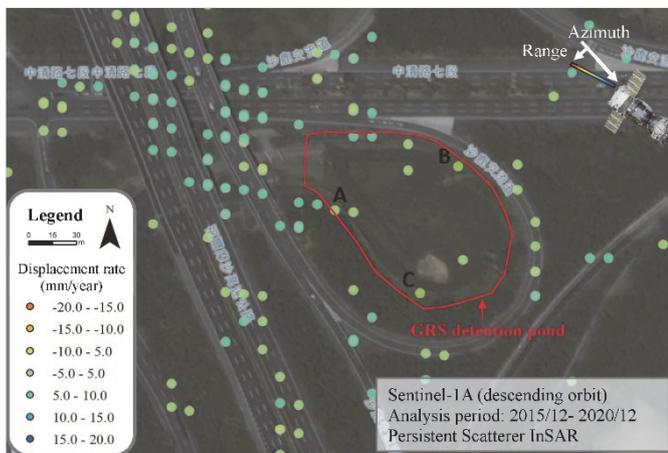
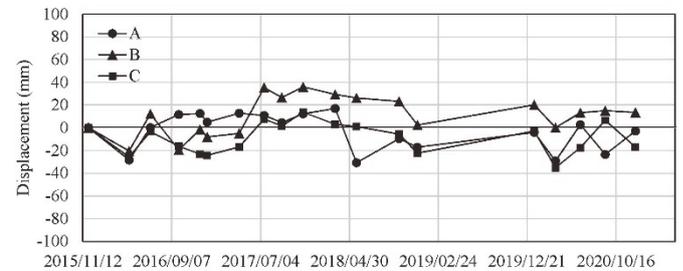
(a) PSInSAR data points

(b) Displacement vs. time of the selected points near the RSS

Fig. 21 PSInSAR data of the surface deformation of the RSS and surrounding area

A remote sensing technique based on persistent scatterer interferometric synthetic aperture radar (PSInSAR) was used to measure the changes in land surface altitude in the project area. This study analyzed 2016 ~ 2020 data from Sentinel-1A, an earth-orbiting satellite, to determine the surface deformation of the RSS and surrounding area (Fig. 21). Figure 21(b) presents the displacement trends with time of the selected points near the RSS. Although the PSInSAR data may exist fluctuations which are the noise from measurement, the average ground displacement rate in vicinity of the RSS was negligible, less than 5 mm/yr over the analyzed period from 2016 to 2020. The satisfactory performance of the RSS indicated by the field observations and PSInSAR data suggests that RSSs with marginal backfill can be applied to waterfront structures if special attention and precautions are taken in design and construction. In addition, the detention pond functions well and thus resolves the flooding problem; no further flooding occurred in the city downstream after the project was completed.
