Landslides

DOI 10.1007/s10346-023-02208-2 Received: 3 August 2023 Accepted: 28 December 2023 © Springer-Verlag GmbH Germany, part of Springer Nature 2024 Shih-Hao Cheng • Kuo-Hsin Yang • Shih-Yuan Lin • Chen-Kan Liao • Hung-Jiun Liao

A modified lift-off test for restressing anchors of a rehabilitated landslide slope

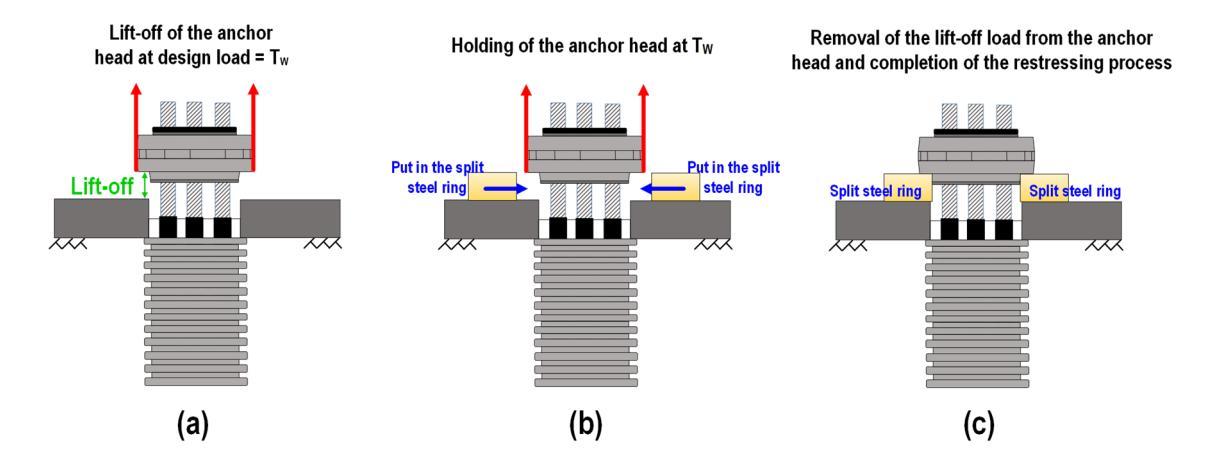
Fig. 3 Restressing of an existing anchor in the modified lift-off test: **a** lift off of the anchor head at the design load, **b** holding off the anchor head at the design load and placing a steel split ring into the gap between the anchor head and the bearing plate, and **c** removal of the lift-off load from the anchor head and the completion of the restressing process

Restressing concurrently with the lift-off test: This restressing procedure involves determining the residual load of the ground anchor using the lift-off test. If the anchor exhibits load loss, the anchoring condition is evaluated through a modified lift-off test. When the creep ratio corresponding to the residual load is deemed satisfactory (indicating good anchoring condition), stress can be applied and increased to the designed load by continuing the modified lift-off procedure. After the stressing has been increased to compensate for the load loss, the restressing process is completed by closing the gap between the anchor head and the bearing plate by using a split steel ring of adequate thickness (Fig. 3). The proposed method, developed by modifying the typical lift-off test, does not require dedicated equipment and does not alter the engaged position of the lock-in wedges on steel strands, thereby avoiding any risk to the weak location of corrosion on the steel strands.

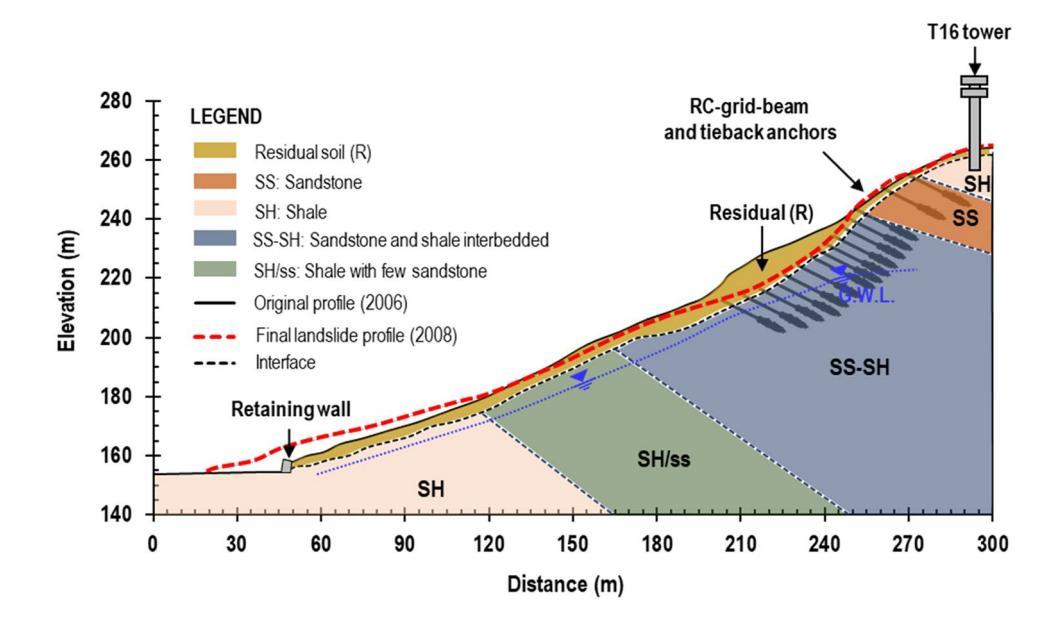
Fig. 5 Cross section of the geometry, geological profiles, and ground anchor installed on the anchored slope near the T16 support tower of the Taipei Maokong Gondola System

tieback structure, were investigated in stage 1. As depicted in Fig. 5, the concrete grid beam structure was supported by a thin layer of residual soil. Following the stress applied to the anchors, the slope surface may experience compression, leading to settlement in the residual layer and causing load loss in the anchors. Based on the aforementioned inference, this study confirmed the geological

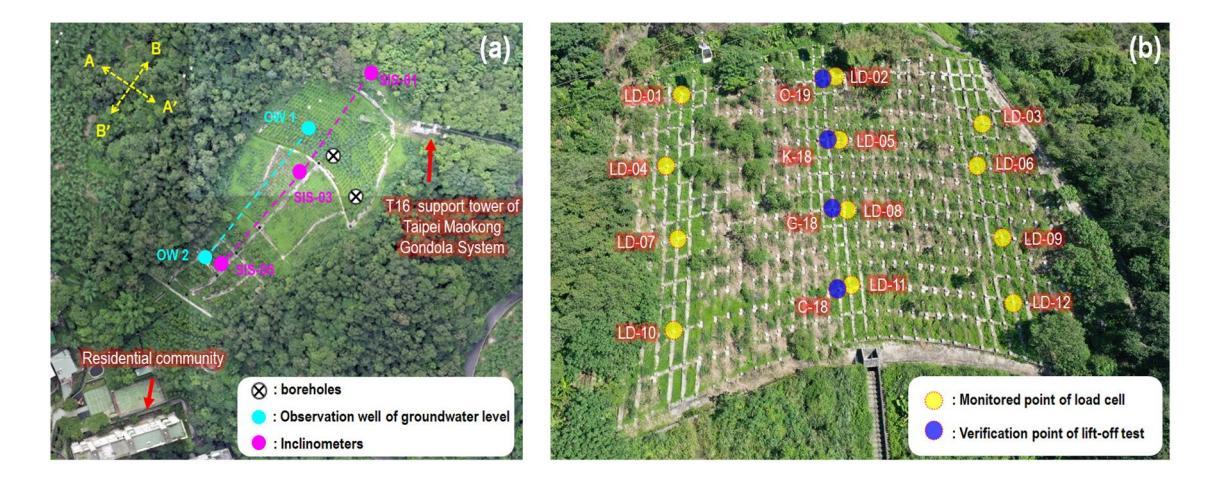
Following the completion of the remediation work on the landslide area, various monitoring devices have been installed on the slope over the past decades. As shown in Fig. 6a, changes in water levels within the landslide area and the movement of the slope section were determined from observation wells and inclinometers, respectively. Additionally, the stress behavior of the ground anchors was monitored by 12 load cells mounted on the anchored slope beneath the T16 support tower (Fig. 6b), and the recorded data provided crucial information on the stability of the base of the T16 support tower. Figure 5 indicates that the groundwater level of the study area is stable and almost constant. The recorded data from the inclinometer and load cell between 2015 and 2020 are discussed below.

The recorded data from the load cell and inclinometer indicated that the landslide area below the T16 support tower remained stable after remediation. However, the reliability of the load cell monitoring data was not ideal. Therefore, this study selected one anchor each (namely, O-19, K-18, G-18, and C-18) from the area adjacent to LD-02, LD-05, LD-08, and LD-11 in the central profile of the anchored slope to perform lift-off tests for verifying the reliability of the monitored data (Fig. 6b). The verification was conducted in September 2020. The results presented in Table 2 indicate that the readings of all load cells, except for the LD-05 load cell, which was damaged, exhibited a relative error of 11%-40% (relative error = $\left(\frac{\bar{T}_{\text{load cell}} - T_r}{T_r}\right) \times 100\%$) compared to the results of the corresponding lift-off tests conducted on the anchors adjacent to these cells. Additionally, the lift-off load did not reflect the stability suggested by the load cell monitoring results; instead, a clear load loss of approximately 2.3-13.7 tons (about 6%-34% T_w) was observed compared with the design load (T_w) .

Fig. 6 Distribution of monitoring devices on the remediation slope: **a** locations of boreholes, groundwater observation wells, and inclinometers and **b** locations of the load cells and locations for lift-off testing

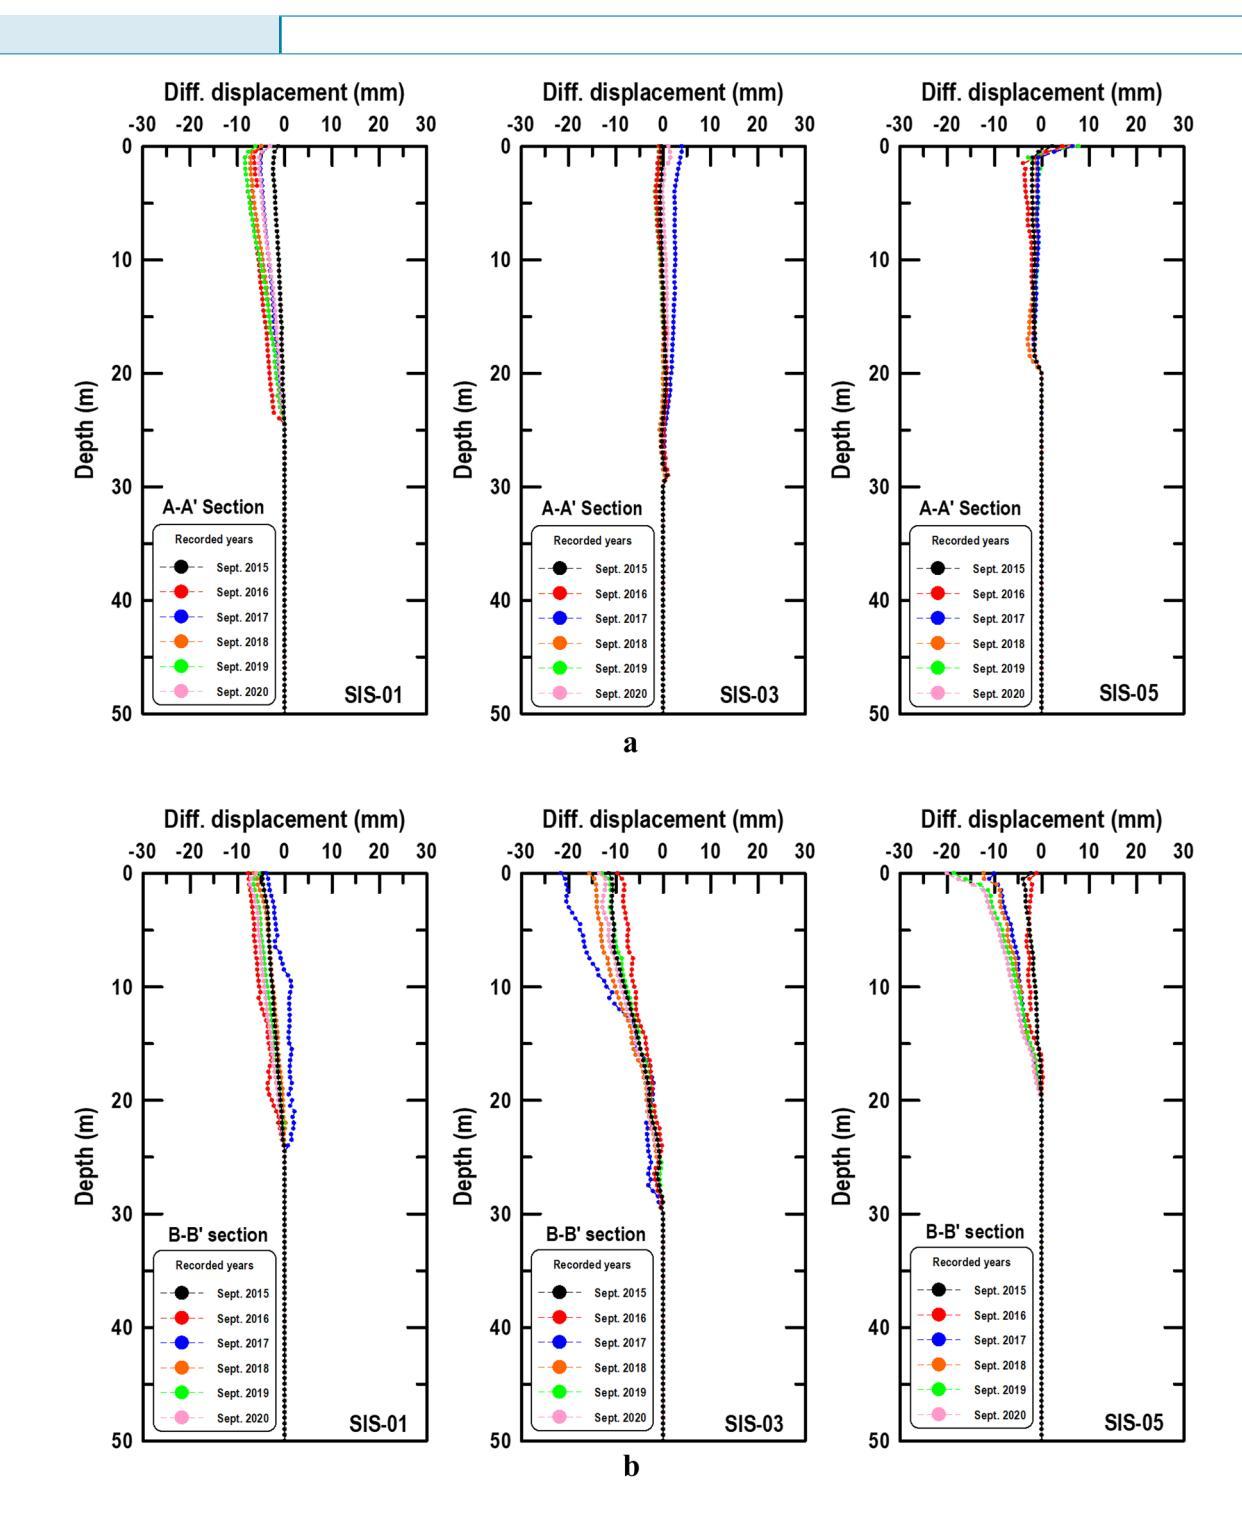
- Slope deformation recorded: Three inclinometers were installed on the slope profile, SIS-01, above the landslide area; SIS-03, within the landslide area; and SIS-05, below the landslide area (Fig. 6a). The monitoring depths of these inclinometers range between 20 and 30 m. The recorded data indicated that the maximum relative displacement in the A-A' section did not exceed 1 cm (Fig. 7a). Furthermore, the maximum relative displacement in the B-B' section did not exceed 2 cm (Fig. 7b), and the data did not indicate the existence of a sliding surface, confirming the stability of the landslide area after remediation.
- Anchor load recorded: In total, 12 load cells were mounted on the anchored slope beneath the T16 support tower. As shown in Fig. 8,

Fig. 7 a Slope displacements recorded from the inclinations between September 2015 and September 2020 (A–A' section). b Slope displacements recorded from the inclinations between September 2015 and September 2020 (B–B' section)

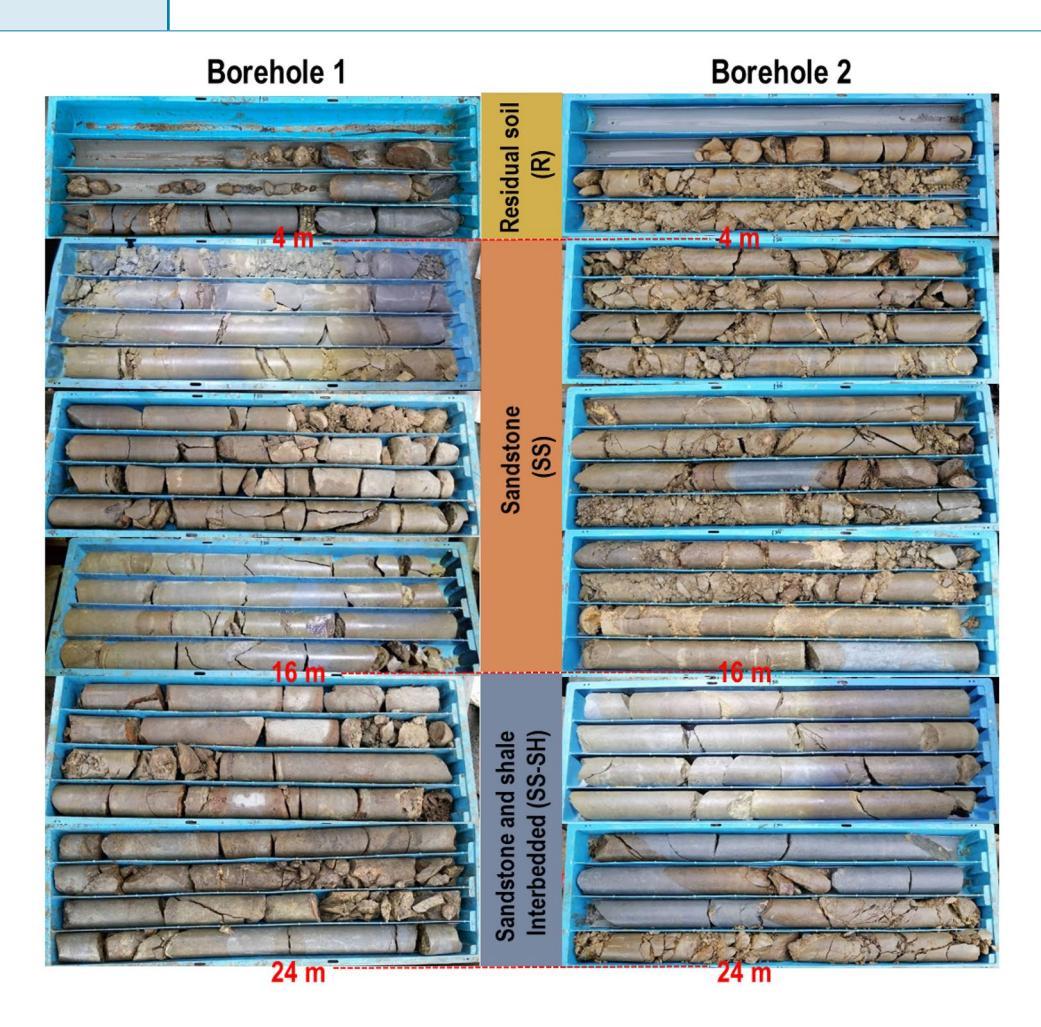
Fig. 11 Boreholes with rock samples obtained from the anchored slope

and shale layers (Fig. 11). This result supports the validity of the earlier inference that identified the residual layer as the cause of the compression and settlement observed in the concrete grid beam.

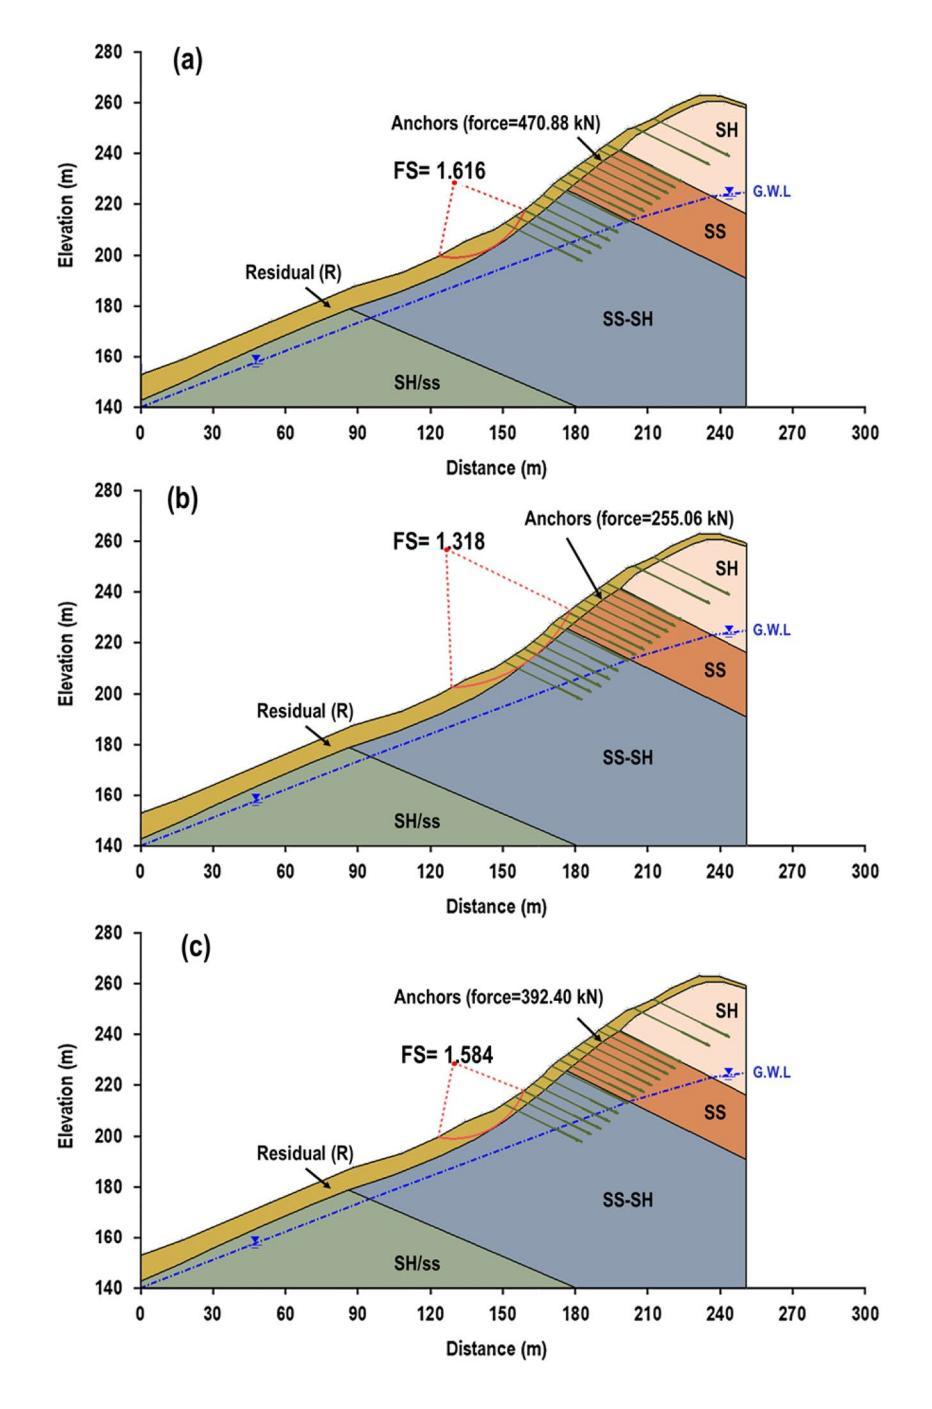
Fig. 13 Results for the FS and critical slip surface of the stability LEM analysis for an anchored slope under different loading conditions: **a** initial stressing condition ($T_0 = 1.2 T_{wr} = 48 \text{ tons}$); **b** load loss condition ($T_r = 0.64$; $T_{wr} = 26 \text{ tons}$); **c** restressing load to design load ($T_w = 40 \text{ tons}$)

SS–SH or SH/ss layers were incorporated to construct the LEM analysis model. The calculated results for FS and the critical slip surface under initial stressing conditions ($T_o = 1.2 T_{w}$) = 48 tons) and load loss conditions ($T_r = 26$ tons) are presented in Fig. 13a, b, respectively. Utilizing the recommended minimum FS values from Duncan and Wright (2005), an FS value of 1.5 signifies slope stability under design requirements. When the average load loss of anchors is below 0.36 T_w ($T_r = 0.64 T_w$, = 26 tons), FS < 1.5 indicates

that the stability of the studied case is lower than the required design criteria. To showcase the contribution of the modified liftoff test in maintaining anchor functionality on the anchored slope, Fig. 13c demonstrates that the average load of ground anchors was restressed to reach T_w (40 tons), resulting in a calculated FS = 1.584, surpassing the stability threshold of FS = 1.5. It indicates the feasibility of the proposed measure for restressing the existing anchors when loading losses.

Based on the results of slope stability analyses under different conditions for the slope, to ensure the anchored slope stability beneath the T16 tower and safeguard the residential community downhill, it is suggested that the load of the anchors experiencing load loss should be increased to the designed load (T_w) through restressing to maintain the design performance. The existing anchors underwent the modified lift-off test to investigate their residual loads, evaluate their anchoring conditions, and synchronize to achieve the restressing. Similar to Fig. 3, when increasing the load to the design load (T_w) , a split steel ring of appropriate thickness must be placed into the gap between the anchor head and the bearing plate by using simple tools to achieve restressing (Fig. 17). Because the load to be increased for each anchor is different, the size of the gap between the anchor head and the bearing plate is not fixed. Therefore, split steel rings with thicknesses of 3, 5, and 10 mm (Fig. 18) were used to provide flexibility in the restressing procedure. In this case, a split steel ring with a thickness of approximately 1.5 mm is required to increase the load by 1 ton {= [ΔP (load charge) × L_{eff} (effective free-strand length)] / [E (Young's modulus of the steel strands) $\times A$ (crosssectional area of all the engaged steel strands)] = $(1000 \text{ kg} \times 15, 0)$ oo mm) $/(2 \times 10^{6} \text{ kg/cm}^{2} \times 4.9355 \text{ cm}^{2})$.

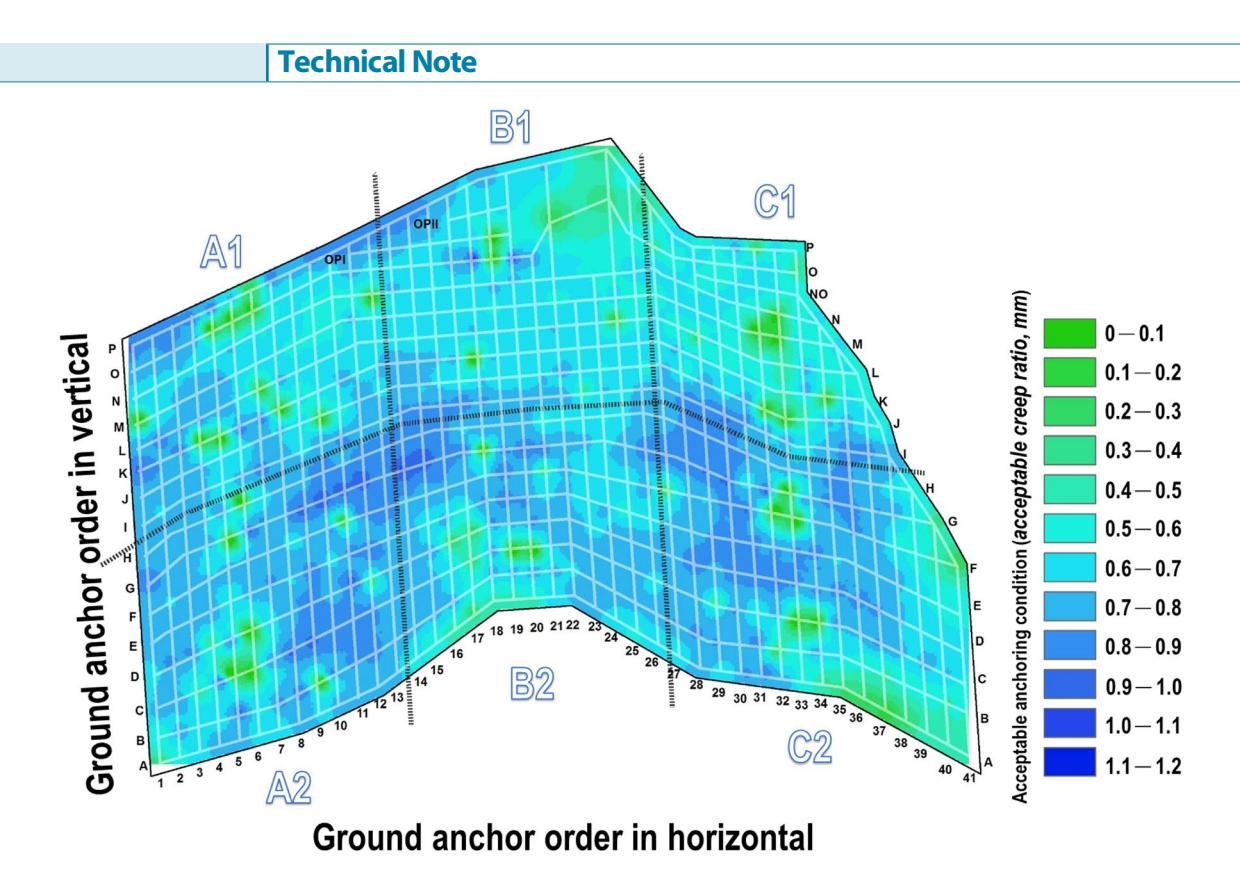
In addition to the residual anchor load, the anchoring condition of each anchor can be evaluated during the modified lift-off test. After obtaining the residual load of each anchor, the $k_{s(L)}$ that must be achieved under maximum lift-off load (T_L) can be calculated using Eq. (2). Figure 15 shows the distribution of the $k_{s(L)}$ that must be achieved for all anchors. Figure 16 shows the distribution of the $k_{s(10)}$ calculated following Eq. (1) by using the measured deformation of the anchorage head when the maximum lift-off load (T_L) was maintained for 10 min during the modified lift-off test. When the $k_{s(L)}$ was greater than the $k_{s(10)}$, the anchoring conditions for all anchors were satisfactory; thus, the creep of the ground anchor system was not the cause of anchor load loss. The obtained data indicate that all inspected anchors satisfy the above condition $(k_{s(L)} > (k_{s(10)}))$. The evaluation results suggest that the load loss was not caused by either anchor corrosion or creep. Instead, it was attributed to compression settlement between the concrete grid beam and the residual soil layer. Furthermore, the load cell data recorded between 2015 and 2020 (Fig. 8) suggests that the anchor load remains constant, as evidenced by the consistent loading trend observed during that period. Therefore, it can be inferred that compression settlement due to construction results in anchor load loss, which may occur suddenly after the tieback anchor was installed and stressed in the year 2010. Engineers could restore the load loss through restressing without necessarily installing additional anchors, thereby saving construction time and costs.

Fig. 15 Distribution contours of acceptable creep ratio $(k_{s(L)})$ (calculated using Eq. (2)) for all ground anchors in the anchored slope

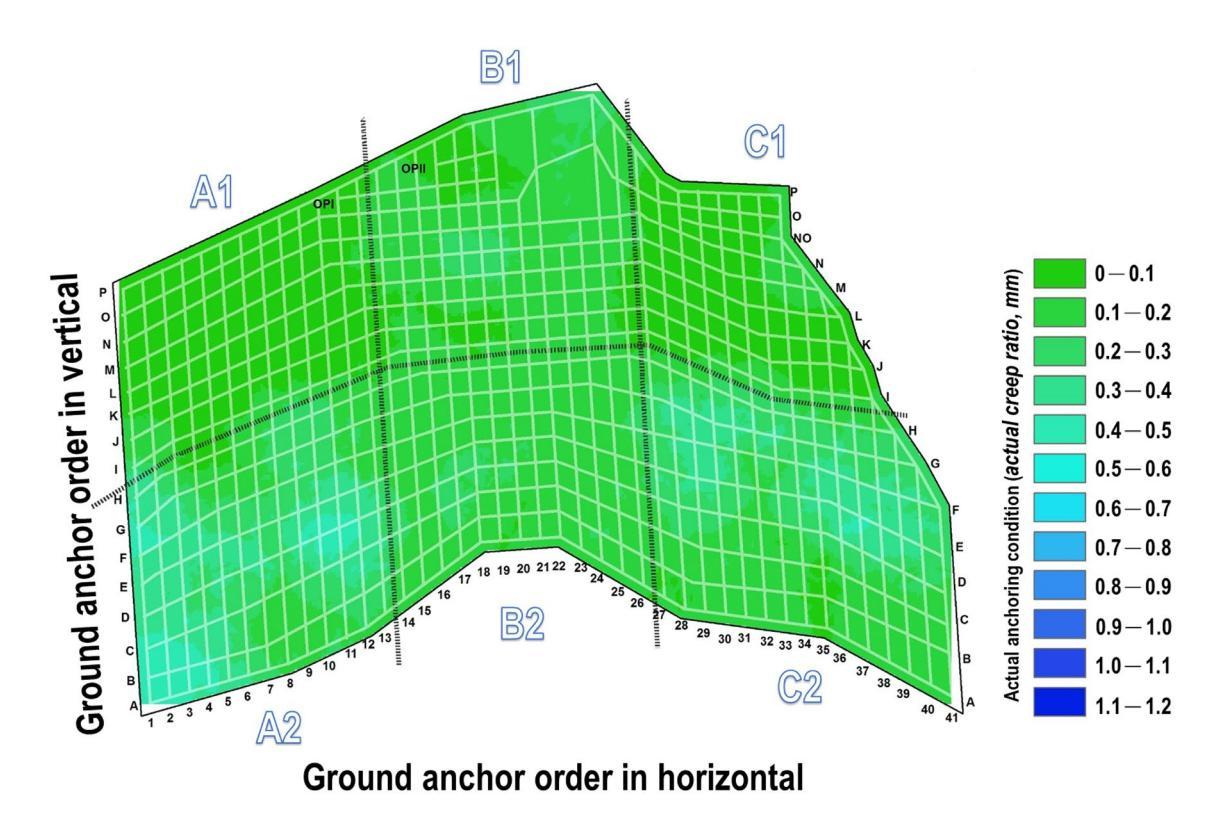
Fig. 16 Distribution contours of actual creep ratio $(k_{s(10)})$ (calculated using Eq. (1)) for all ground anchors in the anchored slope

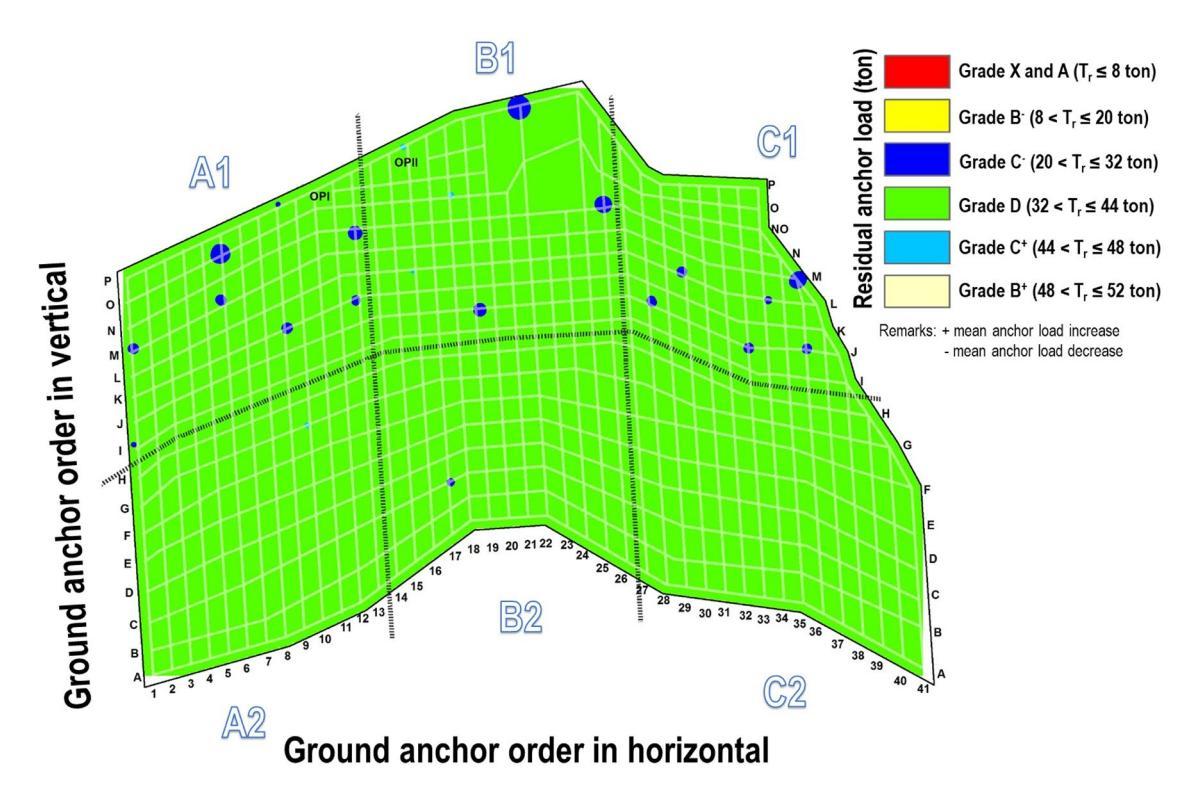
Fig. 20 Load distribution on the anchored slope after reinforcing failed ground anchors

Figure 19 displays the load distribution of all anchors on the anchored slope after performing the modified lift-off test (restressing procedure). It indicates that the loads of most anchors were restored to the design load level (grade D). However, as stated above, during the implementation of the modified lift-off test, approximately 7% of the anchors might fail due to phenomena such as the broken failure of strands and the pull-out occurring at the fixed end. These anchor failures mostly occurred when investigating the residual load and not during the restressing stage, and this study adopted a principle of one-to-one reinforcement for each failure to restore the original design performances. There are 43 reinforced anchors installed on the anchored slope (2 and 41 anchors were reinforced because of failures found during stages 1 and 2 of the investigation, respectively). Figure 20 depicts the load distribution of the anchored slope after reinforcing the anchors; all the anchors were rehabilitated to the design load (T_w) of 40 tons.
