Lessons learned from three failures on a high steep geogrid-reinforced slope

Chia-Nan Liu^{a,*}, Kuo-Hsin Yang^b, Yu-Hsien Ho^{a,c}, Chia-Ming Chang^c

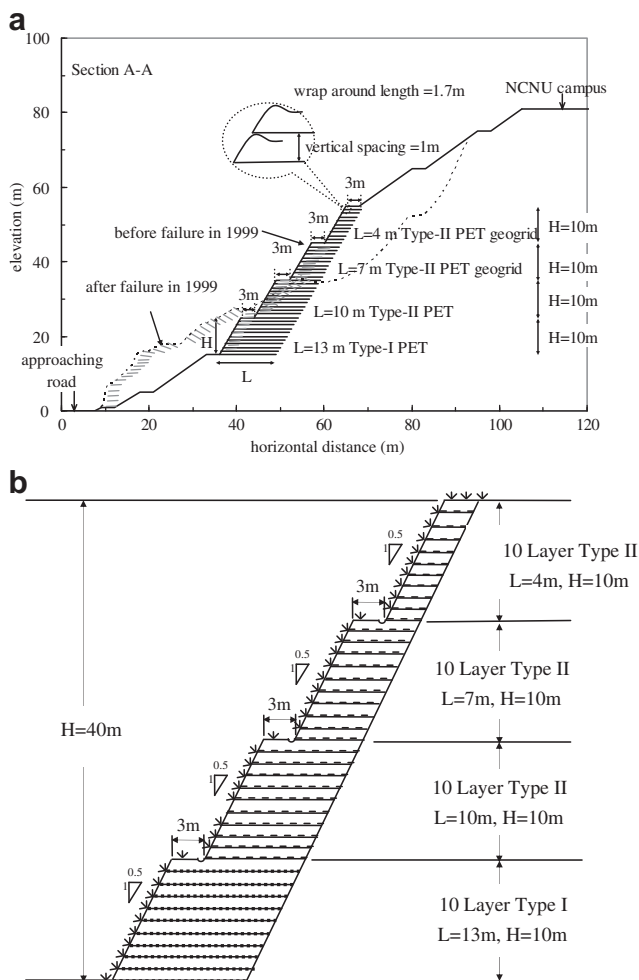
Fig. 2a shows a typical slope profile at Section A-A, which consists of four tiers of reinforced slope underlying an unreinforced soil slope. The unreinforced slope, inclined at about 40°, was built by trimming the pre-construction natural slope. The reinforced slope at Section A-A is 40 m high with a slope angle of 63° (1H:2V). The height of each reinforced slope tier is 10 m and the offset distance is 3 m. The backfill material was taken from the field and compacted in each 1 m lift. The vertical spacing between reinforcement layers is 1 m. There are in total forty layers of reinforcement in this section of reinforced slope. The reinforcement lengths, from the bottom tier to up tier of reinforced slope, are 13, 10, 7, and 4 m in sequence.

Fig. 2. Slope profile at Section A-A: (a) detailed information; (b) original design.

Approximately, an area of 180 m in length by 70 m in height slid down toward the approaching road. The profile after failure at Section A-A is shown in Fig. 2, in comparison with the profiles before failure. The entire four-tiered reinforced slope slid down. An apparent scarp (Fig. 6a), at more than 40 m in elevation, was observed in the natural soil slope located near the slope crest (NCNU campus).

not horizontal as constructed, but rather rotated upslope at a small angle (as shown in Fig. 2). The extrusion of wrapped-around geogrid at some portion can be seen in Fig. 6b, especially at the bottom tier of the reinforced slope. This happened likely due to the large shear force from the sliding soil mass to extrude the wrapped-around geogrid out. Backfills collapsed and slid toward the slope's toe. About 4–5 layers of reinforced slope in the bottom level were not exposed, but they were buried by the geogrid reinforcement that slid down from upslope. No signs of rupture of the geogrid, nor piping, seepage, or moisturized soil were observed in the field. As seen in these photos, the reinforced zone and natural slope slid down along a significant failure surface, which was within the natural soil retained by the reinforced slope. This leads to a conclusion that the failure was closely related to global instability.

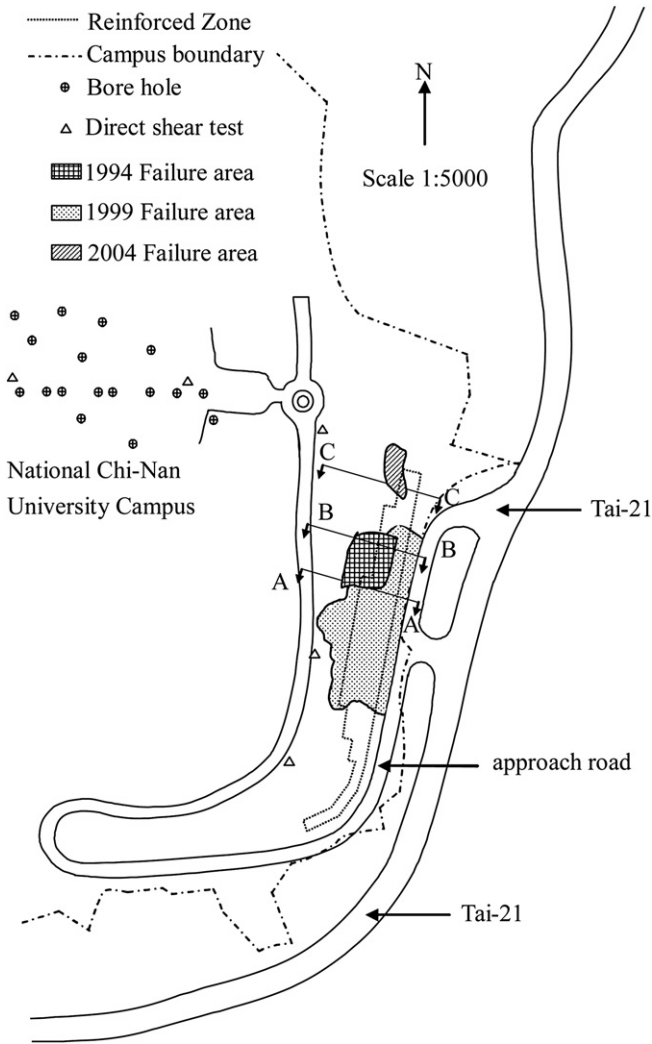
Three failures have occurred on this reinforced slope. The first slope failure occurred during construction in 1994. A second massive failure of the reinforced slope took place after a strong earthquake struck nearby in 1999. The third failure of the reinforced slope happened after a heavy rainfall in 2004. Fig. 3 shows the locations of these failures. This section presents the

Fig. 3. Plain view of the three failures of reinforced slopes.

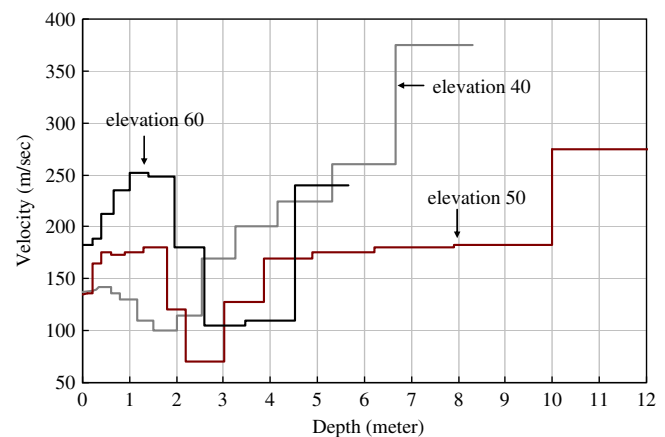
Fig. 9. Shear wave velocity distribution along depth at Section A-A of rehabilitated slope.

wave velocity profile. The boundary between laterite gravel and clay can be easily identified as that point where there is an abrupt change of shear wave velocity. The depth of the clay layer at Section A-A is about 0.5–2.5, 1.8–3.9, and 2.0–4.5 m, respectively, at elevations of 40, 50, and 60 m. By extrapolating these points, the position of the clay layer at Section A-A is shown in Fig. 7. This clay layer has approximately a strike of N25° E and a dip of about 30° to the east. The locations of clay estimated based on the MSASW test results and from field observations of failure and rehabilitation are generally comparable.

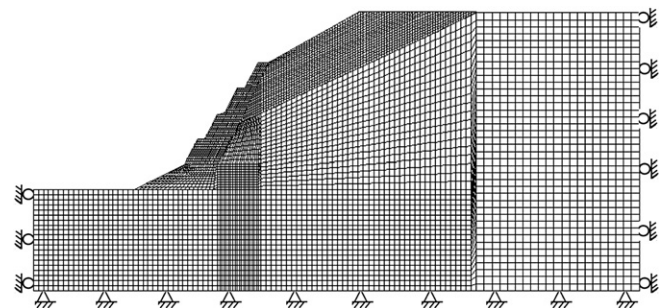
Fig. 10. Finite difference mesh used for modeling Section A-A.

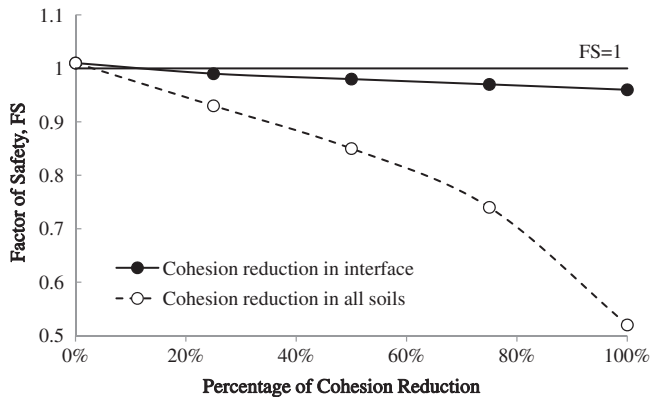
Fig. 11. Variation of FS with different percentages of soil cohesion reduction for the 1994 slope failure at Section A-A.

the slope stability of the reinforced slope at Section A-A for the 1994 slope failure, assuming two scenarios: 1. cohesion reduction in gravel–clay interface; 2. cohesion reduction in all soils. Fig. 11 shows the variation of FS with different percentages of cohesion reduction. Fig. 12 presents the FS contour and the most critical failure surface (white curve), gendered by ReSSA, at dry condition (i.e., no soil cohesion reduction). The limit equilibrium results show the FS = 1.01 at dry condition and decrease to FS = 0.96 at wet condition (i.e., 100% cohesion reduction in interface). FS become further less than 1.0 if 100% cohesion reduction in all soils is assumed. These analytical results suggest the slope was on the margin of instability after the excavation of original nature slope. Further reduction of soil cohesion due to moisture migration would cause the final collapse of the excavated and unprotected slope.

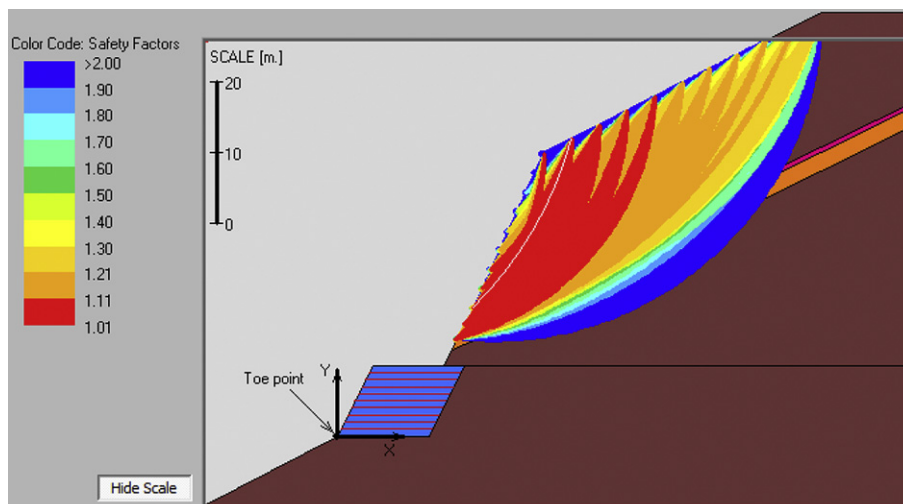
Fig. 12. FS contour and the most critical failure surface of the 1994 slope failure at Section A-A at dry condition.

Fig. 13 shows the contour of maximum shear strain increment obtained from finite difference analyses. The finite difference results reveal that the slope failure was attributed to the stress concentration at the laterite gravel/clay interface. Failure started with a large shear strain that increased at the toe boundary of the lateritic gravel/clay interface and then propagated back into the natural slope until a shallow slide developed. In addition, it can be seen that the critical failure surface identified by the limit equilibrium analysis in Fig. 12 is comparable to the location of

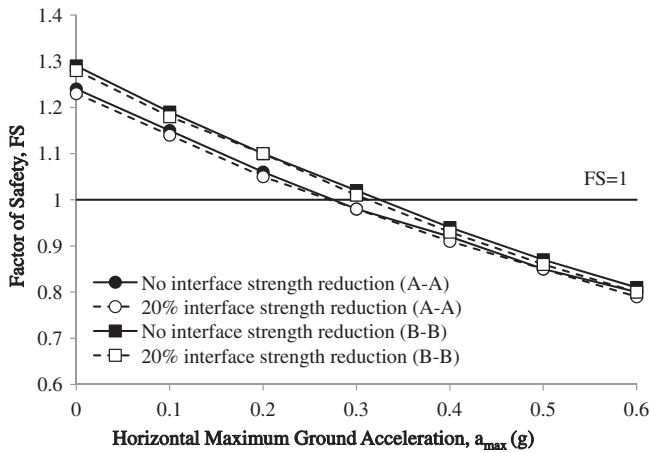
Fig. 14. Variation of FS with different horizontal peak ground accelerations for the 1999 slope failure at Sections A-A and B-B.

Specific important findings are discussed as follows. First, Fig. 14 suggests that the difference between 20% interface shear strength reduction and no reduction is insignificant (less than 1% difference in FS) for the global failure mode identified by the limit equilibrium analyses. The effect of interface shear strength reduction may be important for the direct sliding model along each reinforcement layer. This failure mode was also examined using ReSSA. However, it appears that the most critical mode is the global failure as reported in this study rather than the direct sliding. Second, the analysis results show the slope stability decreases with the increasing a_{\max} . The slopes are initially stable under static condition (i.e., FS = 1.24 and 1.29 for Sections A-A and B-B, respectively) and then turn into unstable (i.e., FS = 1) at a yield acceleration of 0.27 g for Section A-A and 0.32 g for Section B-B. That means, when the a_{\max} greater than the yield acceleration applied on Sections A-A and B-B, the slopes would start to move.

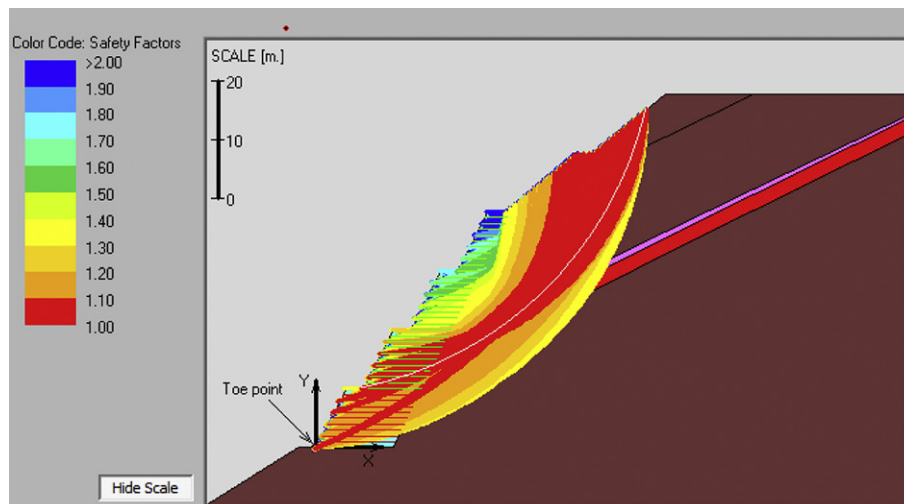
Pseudo-static analyses were conducted using ReSSA to analyze the seismic stability of the reinforced slope for the 1999 slope failure at Sections A-A and B-B. Two scenarios were assumed: 1. no interface shear strength reduction; 2. 20% interface shear strength reduction under seismic loadings. Horizontal maximum ground accelerations a_{max} from 0.1 g to 0.6 g were input as the dynamic loading. As suggested in FHWA (2001), the horizontal acceleration inside the reinforced slope, a_h , equals to one half of the horizontal peak ground acceleration (i.e., $a_h = a_{max}/2$) was adopted in the analyses. Vertical acceleration is not considered in the analyses, assuming the peak vertical and horizontal accelerations do not happen simultaneously. The pore water pressures were ignored, because there had been no piping, seepage, or moisturized soil stratification in the field observation. Fig. 14 show the variation of FS with different horizontal maximum ground accelerations. The FS contour and the most critical failure surface at Section A-A are presented in Fig. 15. Table 3 summarizes the results of the pseudo-static analyses.

Fig. 15. FS contour and the most critical failure surface of the 1999 slope failure at Section A-A (no interface shear strength reduction and $a_{max} = 0.3$ g).

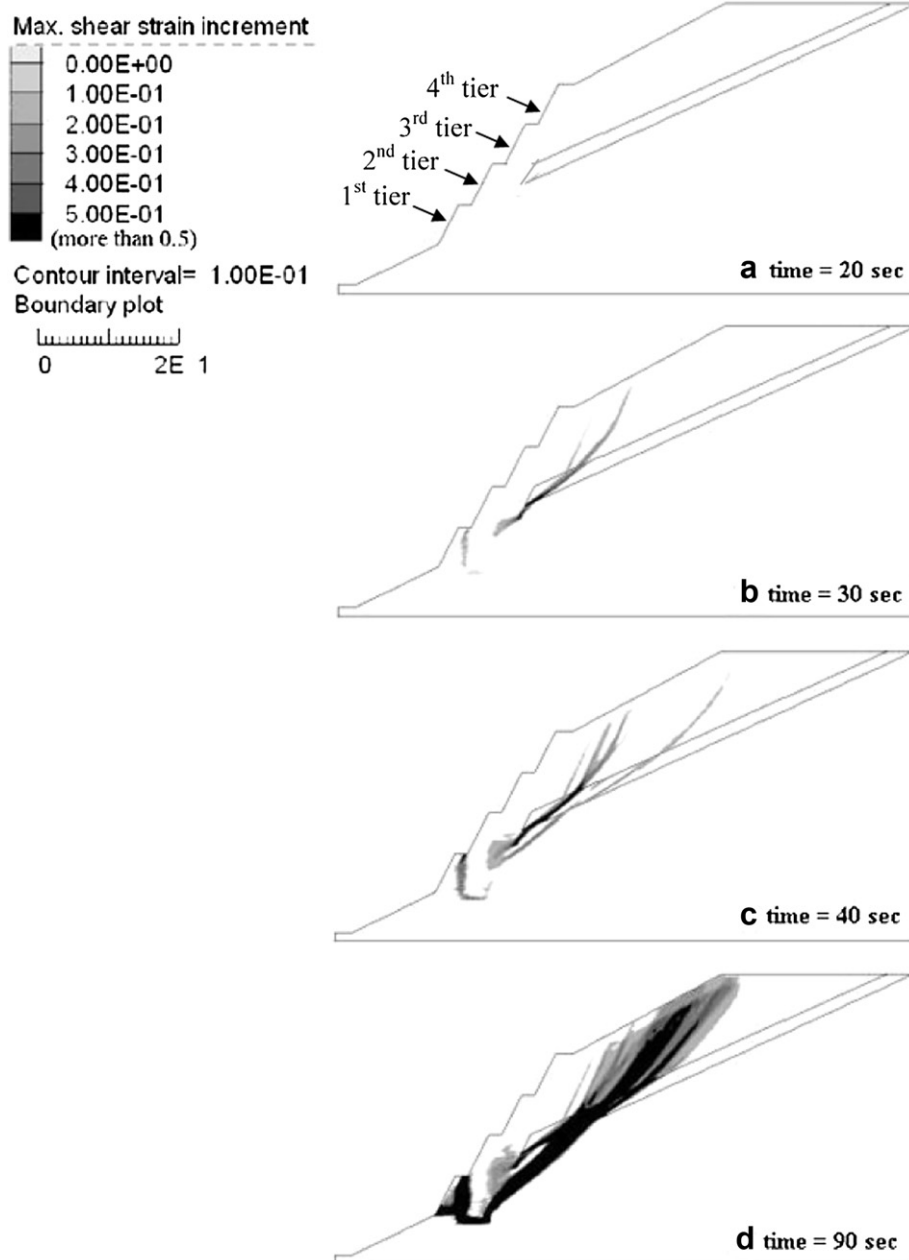
Fig. 16. Shear strain distributions at Section A-A for different times: (a) 20 s; (b) 30 s; (c) 40 s; (d) 90 s.

acceleration occurred at about 30 s, shear strain began to initiate at the back of the backfill zone (Fig. 16b). The stress increment concentrated at zones connecting backfill, clay layer, and natural laterite gravel. This showed that the stress concentration

phenomenon is significant at the point where different materials gather. As the magnitude of earthquake loading increased with time, the induced shear strain within the slope increased accordingly. For example, at 40 s when peak ground acceleration occurred, the distribution of induced shear strain was more significant (Fig. 16c). The zone and magnitude of induced shear strain kept enlarging until 90 s (Fig. 16d) when there was no more massive ground acceleration. This clearly illustrates an external failure in that most of the shear strain was concentrated at the region where the backfill zone and the natural soil zone connected and compares well with the observed failure scarp as shown in Fig. 2. Fig. 17 shows the comparison of failure surface locations for the 1999 slope failure at Section A-A. Three failure surfaces from field observation, limit equilibrium analysis and finite difference analysis match reasonably well.

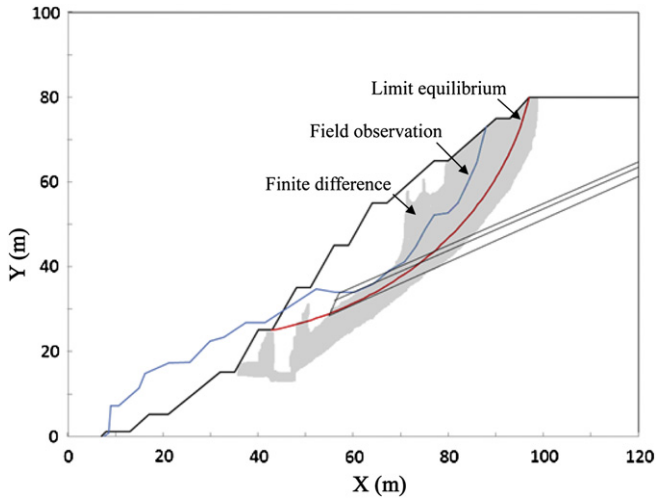
Fig. 17. Comparison of failure surface locations of the 1999 slope failure at Section A-A.

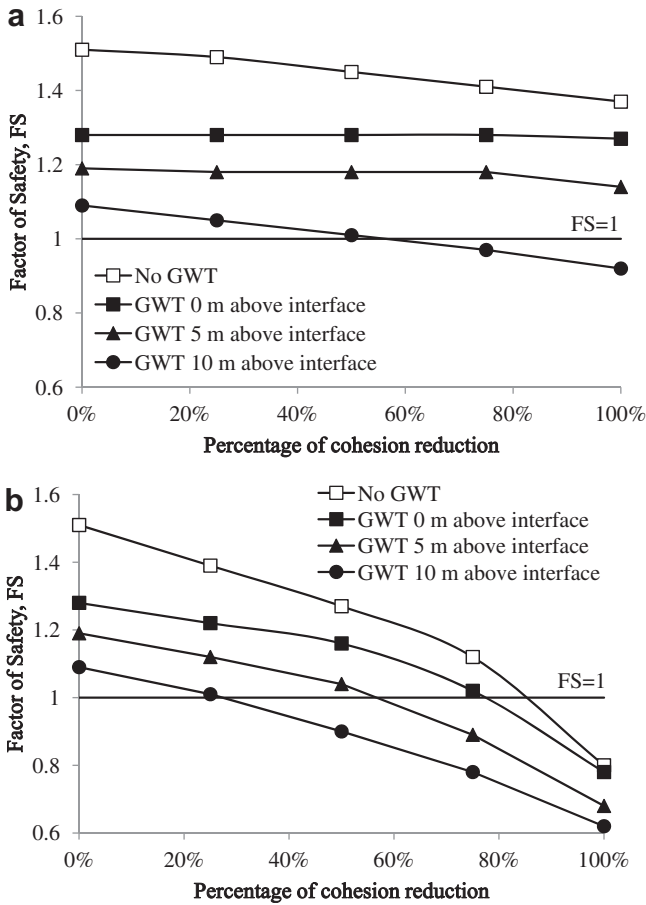
Fig. 19. Variation of FS with different percentages soil cohesion reduction and GWT levels for the 2004 slope failure at Section C-C: (a) cohesion reduction in interface; (b) cohesion reduction in all soils.

is initially stable (i.e., $FS \approx 1.5$) at no ground water table and no soil cohesion reduction. The slope develops to be instable (i.e., $FS = 1$) when the GWT level and the percentage of soil cohesion reduction reach a certain combination. Limit equilibrium results, shown in Fig. 19, can justify that the assumption of cohesion reduction in all soils is closer to the real field condition. That is because failure of the reinforced slope ($FS < 1$) occurs in the scenario of cohesion reduction in all soils when the GWT level is 5 m or less above the interface. The 5-m of GWT level above the interface in the limit equilibrium analyses can produce the water pressure distribution similar to the value calculated from the transient seepage analyses. However, there is no slope failure occurs in the scenario of cohesion reduction in interface; the result based on the assumption of cohesion reduction in interface contradicts to the field observation. Fig. 21 shows the comparison of failure surface locations. The locations of failure surfaces from field observation and limit equilibrium analysis match reasonably well but differ from that from finite difference analysis. The possible reason is because it is difficult to model the pore water pressure distribution in the field accurately. It also can be observed in Fig. 21 that the failure surfaces searched by limit equilibrium analyses are sensitive to the GWT level.

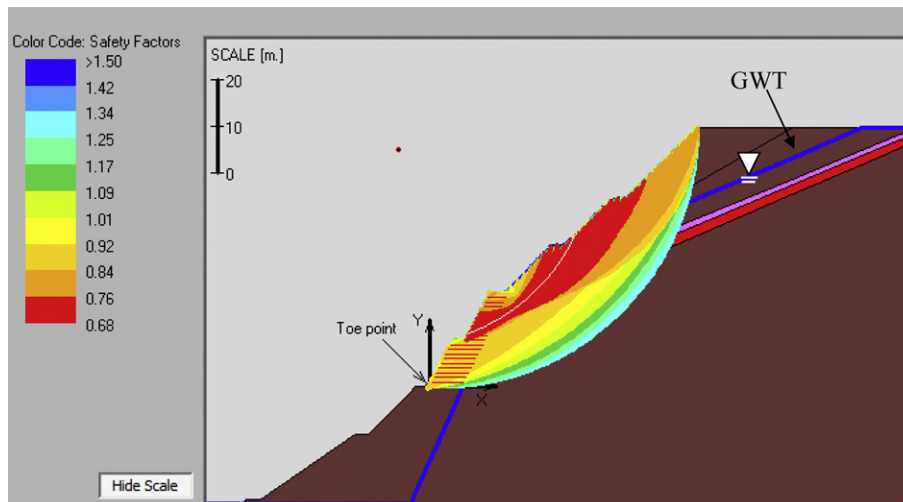
Limit equilibrium analyses were also conducted to evaluate the slope stability for the 2004 slope failure at Section C-C. The pore water pressures were simulated using various ground water table (GWT) levels from 0 m to 10 m above the interface layer. Similar to the 1994 failure case, two scenarios were considered: 1. cohesion reduction in gravel–clay interface; 2. cohesion reduction in all soils. These two scenarios were to simulate the reduction of soil shear strength and the loss of apparent cohesion that possibly occurred in the field due to moisture migration and absorption. Fig. 19 shows the variation of FS with different percentages of cohesion reduction and GWT levels. The FS contour and the most critical failure surface are presented in Fig. 20.

Fig. 20. FS contour and the most critical failure surface of the 2004 slope failure at Section C-C (100% cohesion reduction in all soils with GWT level 5 m above interface).

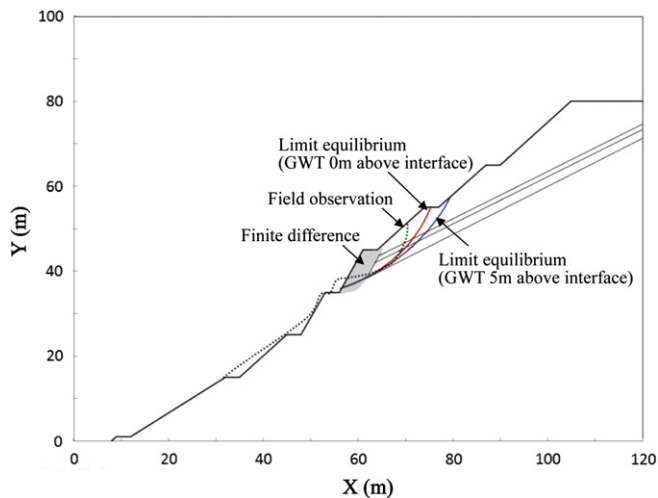
Fig. 21. Comparison of failure surface locations of the 2004 slope failure at Section C-C.
